UPPER JUKSKEI RIVER CATCHMENT REHABILITATION

FRESHWATER SPECIALIST STUDY

Advisian

July 2018

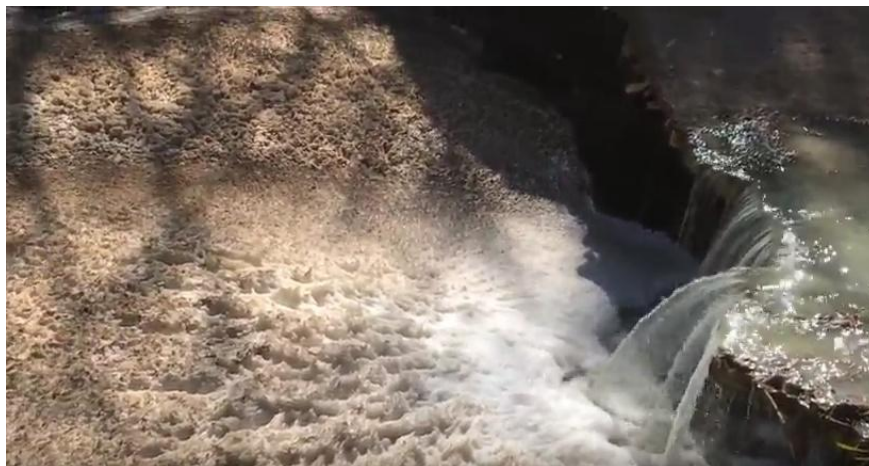
Figure 4. Sewage pollution in the tributary of Eastleigh Stream at Beverley Avenue, Highway Gardens (Irwin Jukes, July 2018).

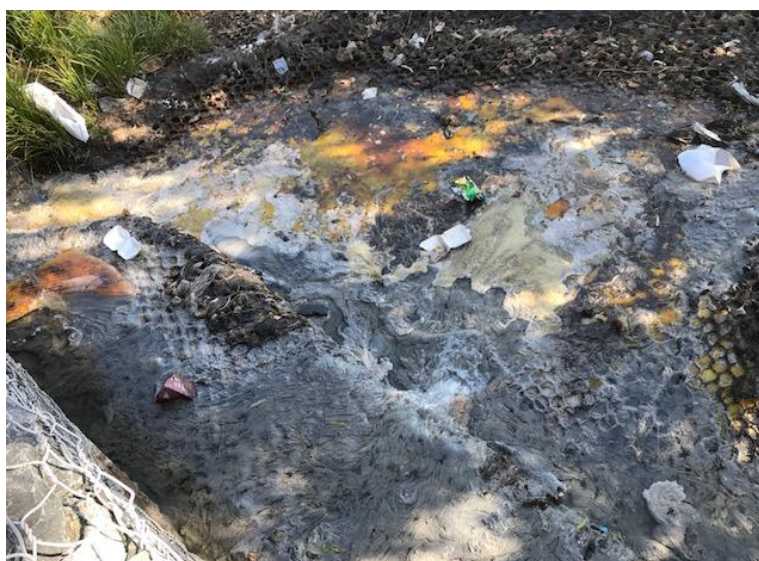
In addition to sewage, industrial pollution also originates from somewhere near Klopper Park, but it remains a challenge to identify precise source locations on a more specific level without going 'door to door' and 'pipe to pipe' (Figure 5).

Figure 5. Pollution (sewage and industrial) in a channelized section of the northern tributary of the Eastleigh Stream originating in Klopper Park (Irwin Jukes, 15 June 2018).

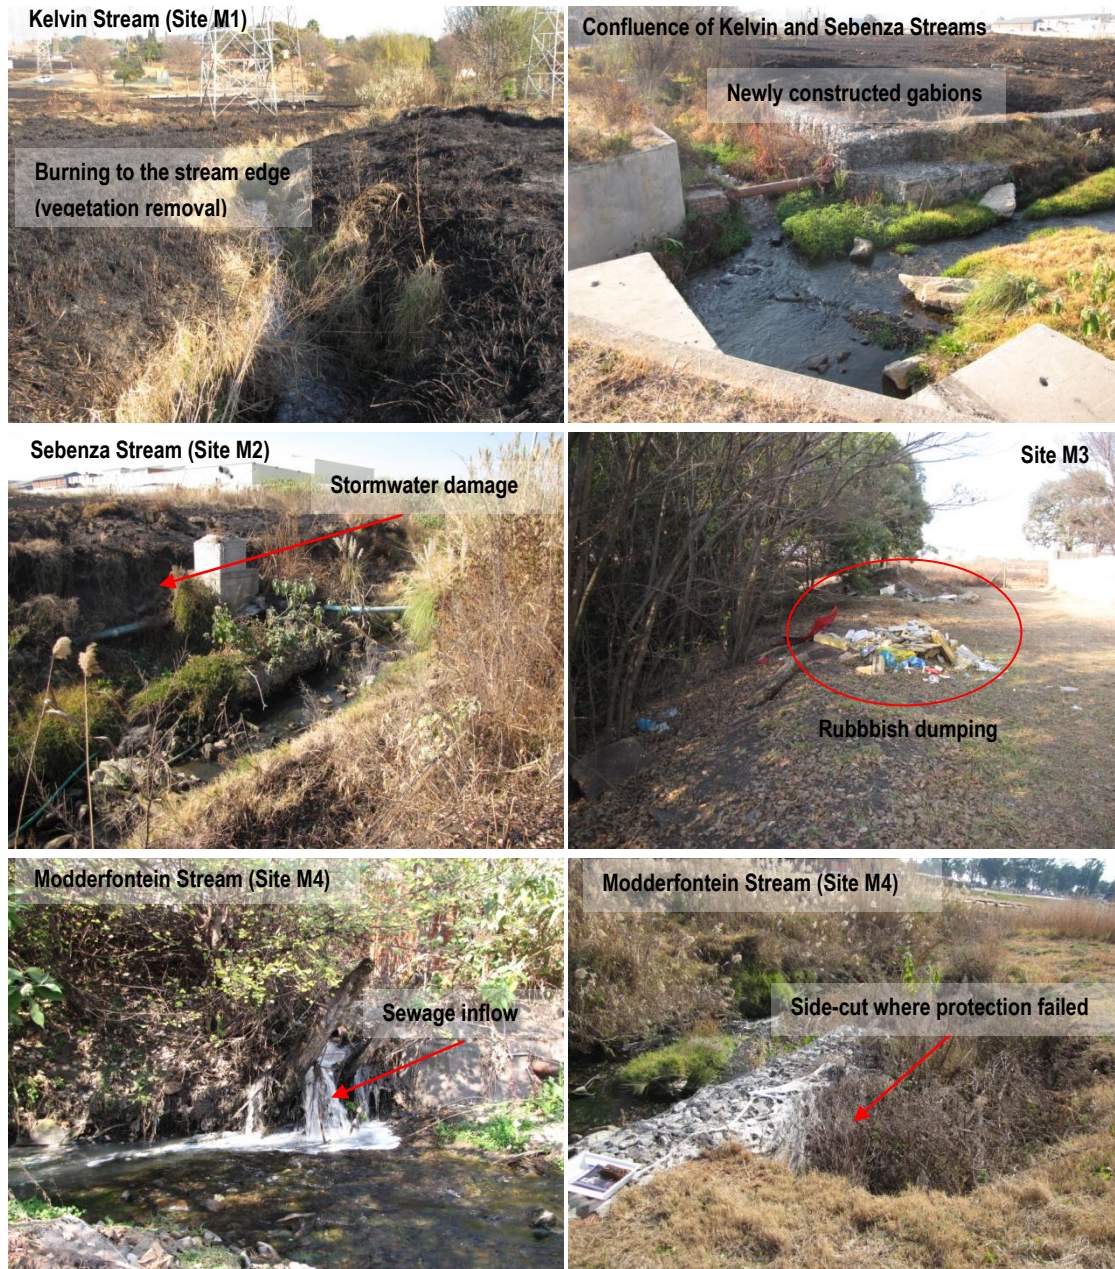
Channel modification	18 (4)	Channel enlarged and incised by floods, and infrastructure such as bridges, culverts etc.;
Water abstraction	0 (3)	None that is affecting the riparian zone.
Inundation	3 (3)	Very few locations where inundation upstream of infrastructure (e.g. weir) causes inundation and loss of the riparian zone.
Flow modification	10 (4)	Increased and seasonally sustained flows related to urban development have resulted in a more developed riparian zone compared to historical images.
Physico-chemistry	0 (4)	In most cases the channel is so deep and incised that riparian vegetation is barely influenced by instream water chemistry.
RIPARIAN INTEGRITY CLASS = F, CRITICALLY MODIFIED

Figure 13: Photographs showing some of the impacts considered in the Index of Habitat Integrity for the Modderfontein Stream.

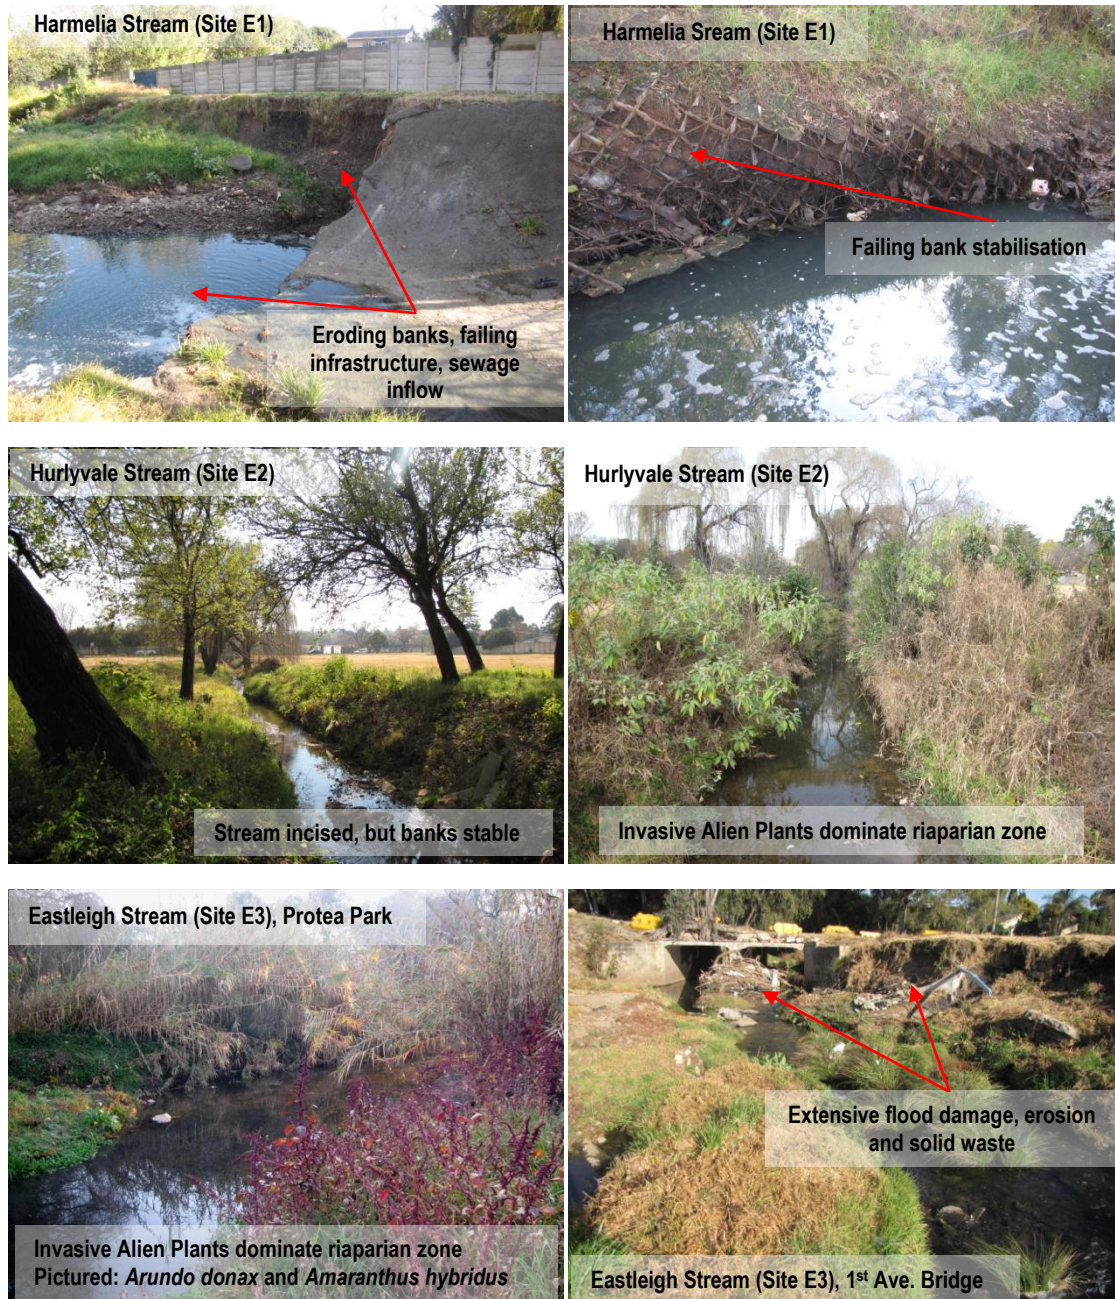
Channel modification	18 (4)	Channel enlarged and incised by floods, and infrastructure such as bridges and culverts
Water abstraction	0 (3)	None that is affecting the riparian zone.
Inundation	10 (3)	Inundation at Horwood's Farm at the dam, but not a major impact elsewhere.
Flow modification	10 (4)	Increased and seasonally sustained flows related to urban development have resulted in a more developed riparian zone (dominated by aliens) compared to historical images.
Physico-chemistry	3 (3)	In most places the channel is deeply incised, piped or canalised, effectively separating the riparian zone from the water.
RIPARIAN INTEGRITY CLASS = F, CRITICALLY MODIFIED

Figure 14: Photographs showing some of the impacts considered in the Index of Habitat Integrity for the Eastleigh Stream.

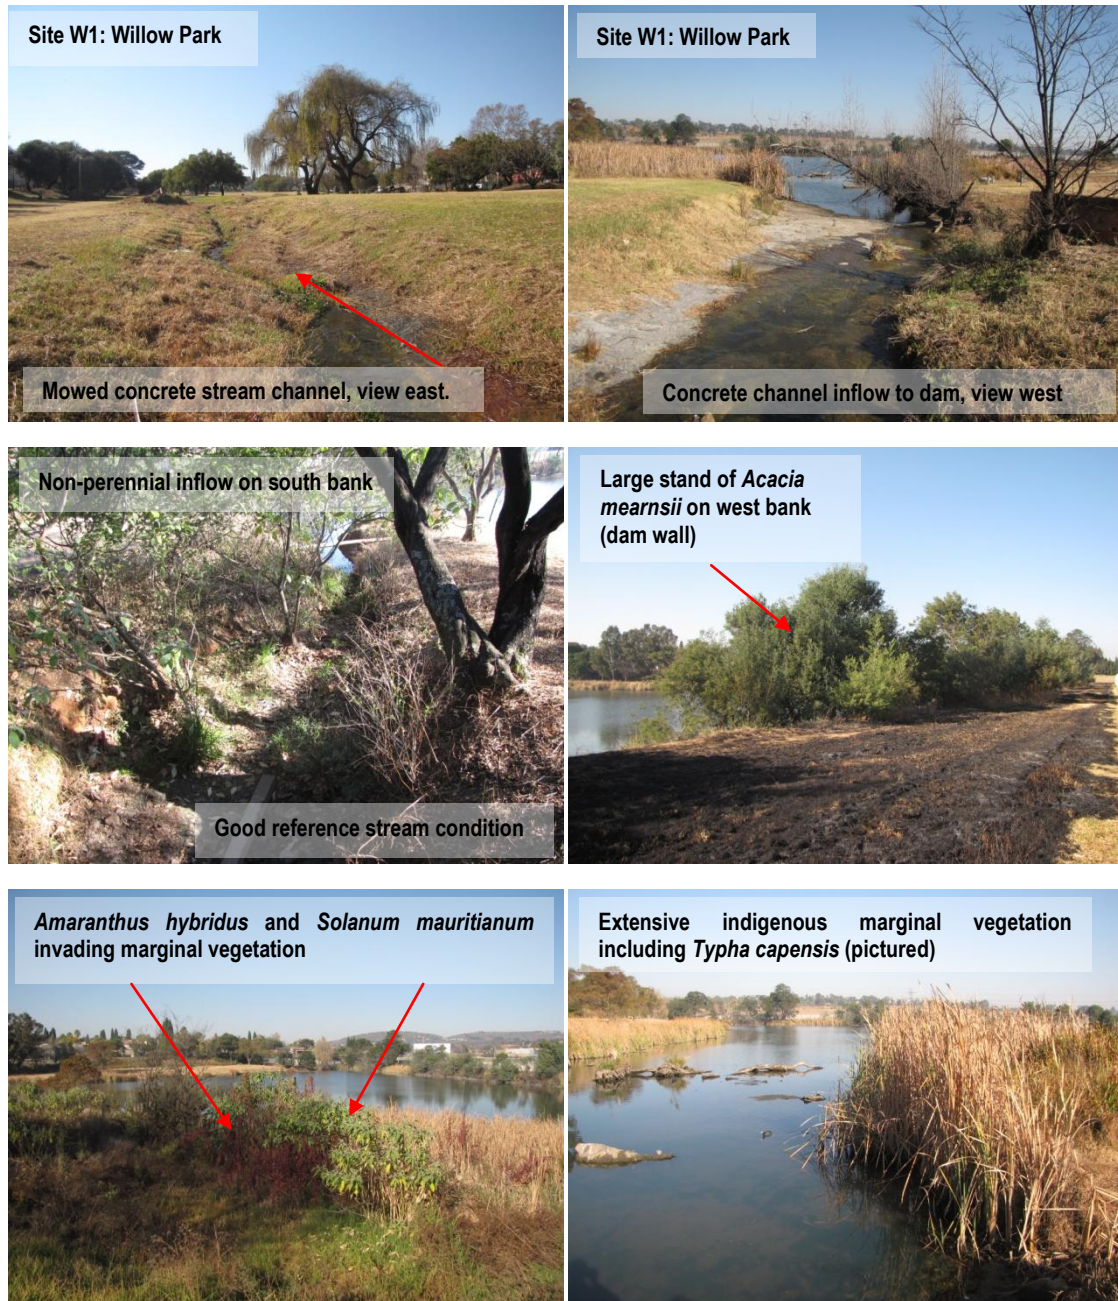
RIPARIAN INTEGRITY CLASS = E / F, SERIOUSLY TO CRITICALLY MODIFIED

Figure 15. Photographs showing some of the impacts considered in the Index of Habitat Integrity for Willow Park.

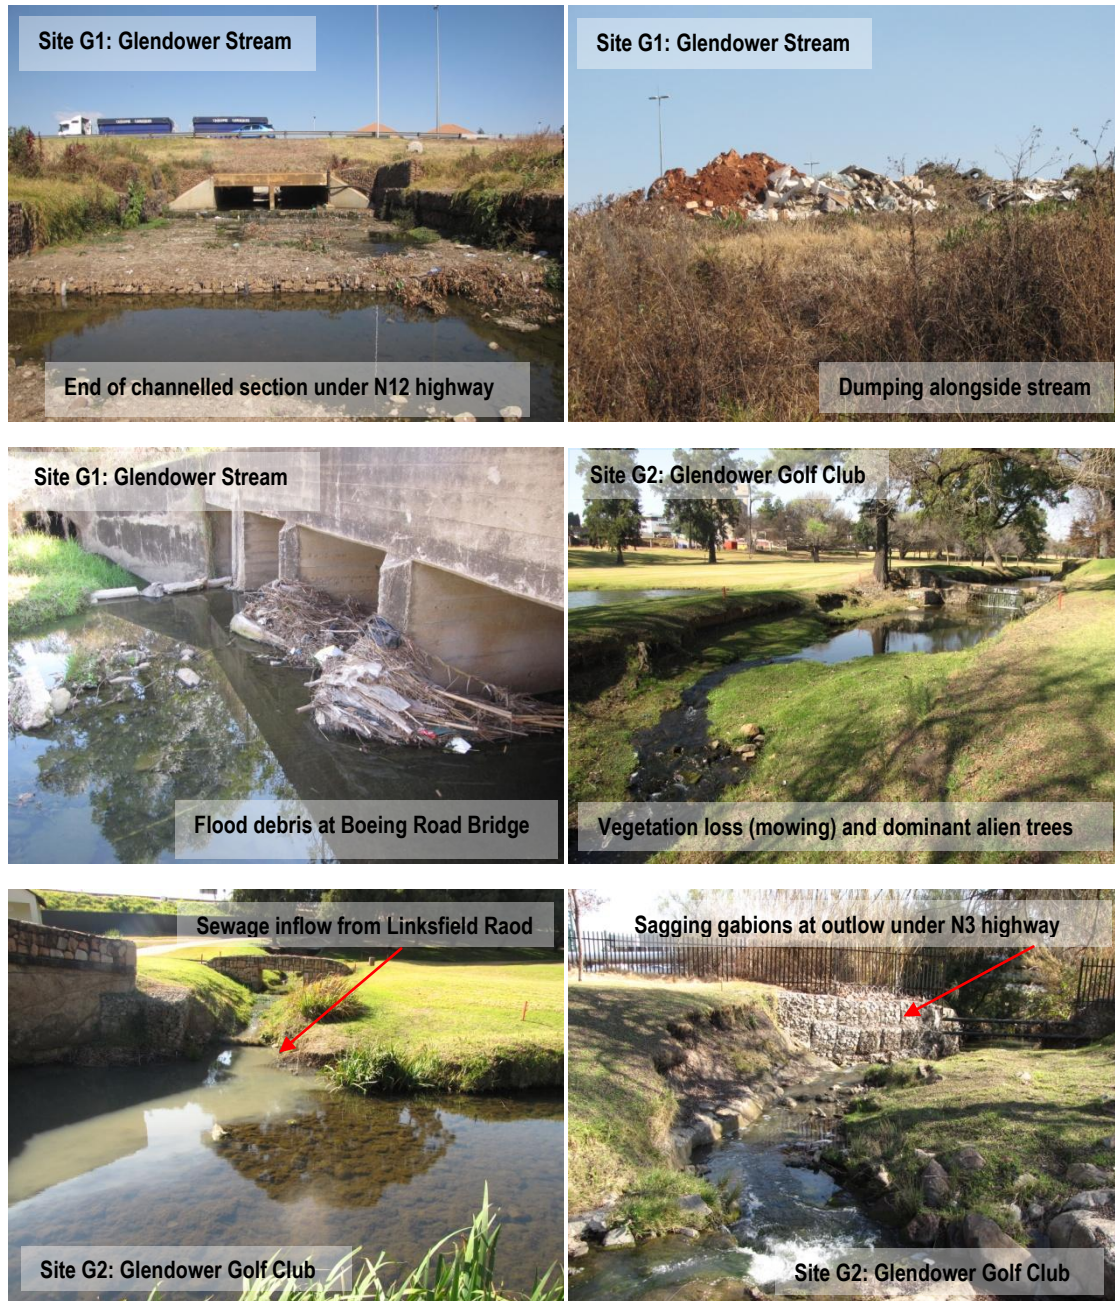
Flow mod.	15 (3)	Flow reduced to lotic conditions at impoundments which favours different riparian species, increased flood flows and overtopping banks causes damage to the riparian zone.
Physico-chemistry	10 (2)	Nutrient enrichment would increase the density of marginal vegetation which is mainly exotic.
RIPARIAN INTEGRITY CLASS = F, CRITICALLY MODIFIED

Figure 16. Photographs showing some of the impacts considered in the Index of Habitat Integrity for Glendower Stream.

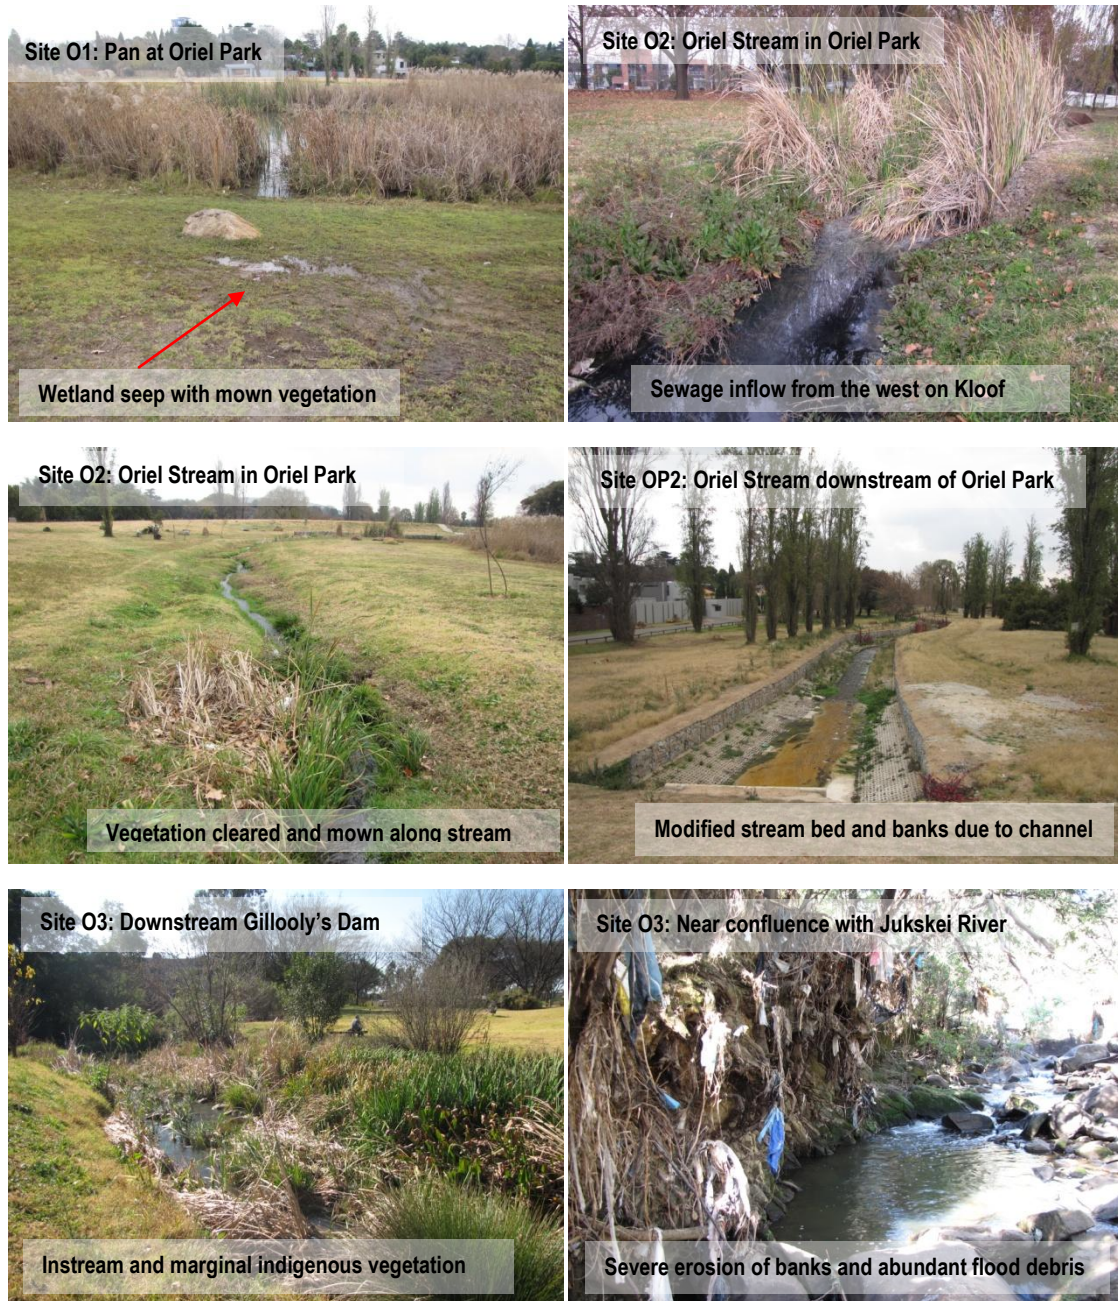
Water abstraction	0 (3)	No known water abstraction.
Inundation	15 (4)	Gillooly's Dam has resulted in the inundation of an extensive area of the riparian zone of the original stream.
Flow mod.	10 (2)	More frequent flood events may damage the riparian zone.
Physico-chemistry	5 (2)	Increased nutrients due to eutrophication may result in increased marginal vegetation.
RIPARIAN INTEGRITY CLASS = E / F, SERIOUSLY TO CRITICALLY MODIFIED

Figure 17. Photographs showing some of the impacts considered in the Index of Habitat Integrity for Oriel Stream.
