MBASHE RIVER TRENDS REPORT (2007-2010)

DEPARTMENT OF WATER AFFAIRS

RIVER HEALTH PROGRAMME

NOVEMBER 2010

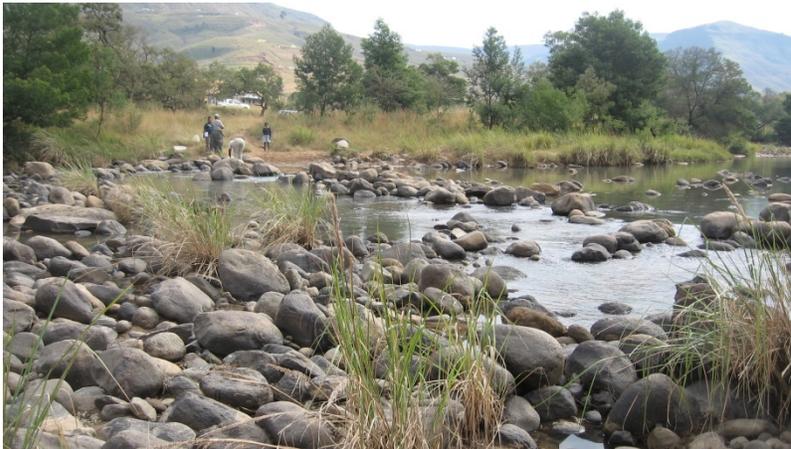
Site1

This is a pool-rapid site although riffles and bedrock fall are also present. Downstream of the site there is a lot of sand bars with no vegetation. Alien vegetation infestation is also evident along the river reach, while the indigenous vegetation had been removed. Bank undercut, livestock paths, hillslope erosion and subsistence agriculture (maize field) could be observed. These play a significant part as source of sediment in the river channel, hence non-vegetated mid-channel and lateral bars in the active channel. As a result of sedimentation, biotope abundance and diversity might have been lost downstream. However, upstream of the site different habitat types are plentiful. Thus it can be concluded that the river at that reach is moderately modified because of change in natural and biota that occurred though basic ecosystem functioning appears primarily unimpacted (C class).

Fig.6. Photograph of Site 1 (Mbashe Upper) showing the diversity of biotopes and substrate.

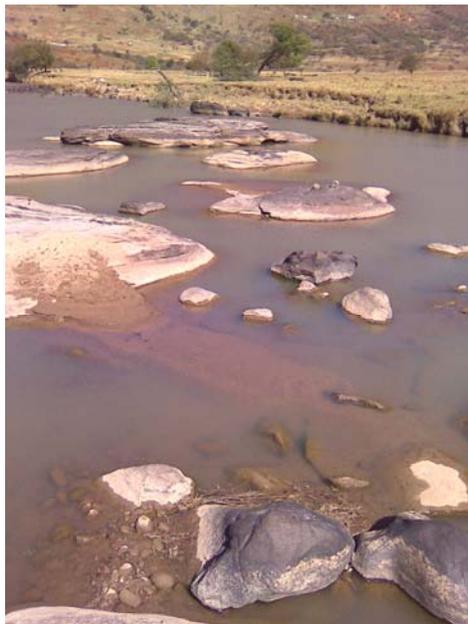
The site is located on the tributary of Mbashe River in the upper reaches. This is the mixed channel dominated by bedrock, but boulders and cobbles are also present as dominant morphological units. There is evidence of vegetated island bars, suggesting that there has been sediment input in the site, though it does not occur more frequently hence growth in vegetation. The site is also invaded by alien plants (namely *Eucalyptus spp.*). This, together with animal trampling and vegetation removal results in sheet erosion and consequently riverbank failure, which also contribute to sediment input in the site. Due to this, diversity of habitat types may have been reduced. Since the river channel is expected to widen, water temperatures can increase as well, due to rapid penetration of sunlight, which can also result in decline in dissolved oxygen.

It can be argued that the river is moderately modified in the site as there is no recognized development in the adjacent hillslope and the flood plain (C class).

Fig. 8. Photograph of Site 3 (Silindini) showing the diversity of biotopes and substrate.

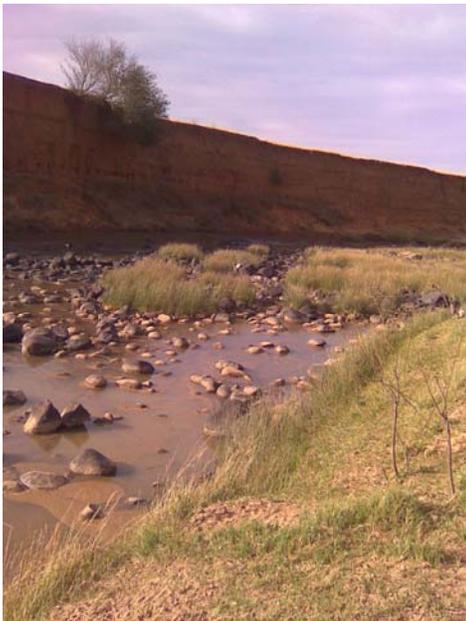
The site is a pool-riffle system and an alluvial channel (consisting of boulders, cobbles, gravel and sand). The water was very turbid during site visit suggesting a lot of fine sediment input. Vegetated bars show that the channel bed is becoming stable. Both alien and indigenous vegetation were sparse, i.e. there is an evidence of vegetation removal (especially trees and shrubs). The riverbank on the right is stabilized by short grass (*Cynodom dactylon*). Bank failure occurs on the left bank acting as a source of sediment at a local scale, hence the availability of different kinds of bars. However, this alternation of deposition and erosion is a typical characteristic of a meandering river. Therefore in terms of geomorphology the river can be classified as D.

Fig. 10. Photograph of Site 5 (Xuka Mhlophekazi) showing the diversity of biotopes and substrate.

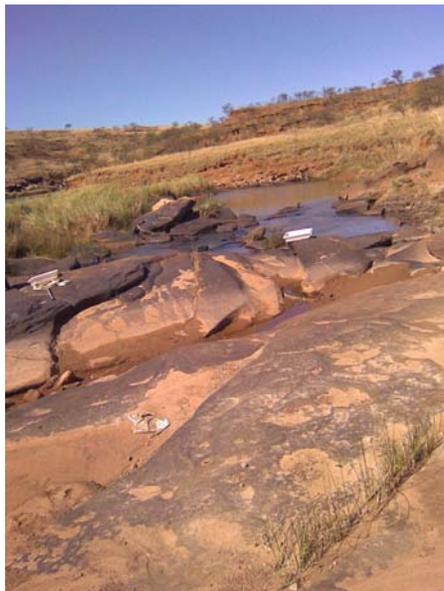
This is another site located on the tributary of Mbashe River, Mgwali. The channel on a site area is a mixed channel, with bedrock and alluvium. Because the site is on the upper reaches of the catchment, it is characterized by v-shaped valley but due to overgrazing, there is a lot of sheet erosion. As a result, the sediment is transported to the main stream and consequently there are island bars along the entire reach. Gullies can also be noticed in the hillslope, contributing a lot of sediment to the river. The bridge upstream of the site has noticeable impact on the river 'health' as it traps the sediment and converting the magnitude and direction of natural flows. Construction of bridge on the site and presence of invasive alien plants can contribute to localized disturbance to river bed and bank. In addition, the bridge constructed on the river can hinder the movement and migration of invertebrates and fishes, causing them to be stuck and therefore vulnerable to predation. Condition of local catchment, e.g. livestock, alien invasion, bridge construction, gabion structures and massive erosion mean that the habitat quality, diversity and size have been largely impacted (Class D).

Fig. 11. Photograph of Site 6 (Mgwali R61 bridge) showing the diversity of biotopes and substrate.

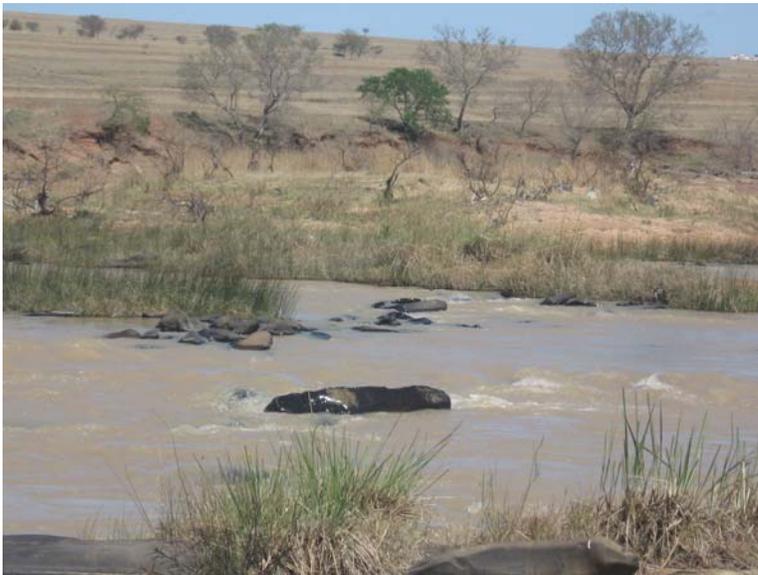
This is the tributary of Mbashe River, which is a mixed channel (bedrock, boulders and cobbles). It is a pool-rapid system although runs and riffles also exist. Livestock trampling, sediment mining, alien invasion, gravel roads and bridge could have negative impact on morphology of the river system. Sediment mining, gravel roads and bank erosion serve as sources of sediment on the riverbed. However the impact of the bridge on the riparian zone has been minimized by anti-erosion structures (gabions). Bars with various morphological units serve as medium for vegetation growth hence sedges and grass on some of them. Irrigation scheme upstream could also be noted as it could reduce base flows, which can result in sedimentation as well. For these reasons, the river at a reach can be judged as moderately modified (C category) because there has been a decrease in natural habitat though basic ecosystem functioning is predominantly unchanged.

Fig. 12. Photograph of Site 7 (Mgwali Ngcacu) showing the diversity of biotopes and substrate.

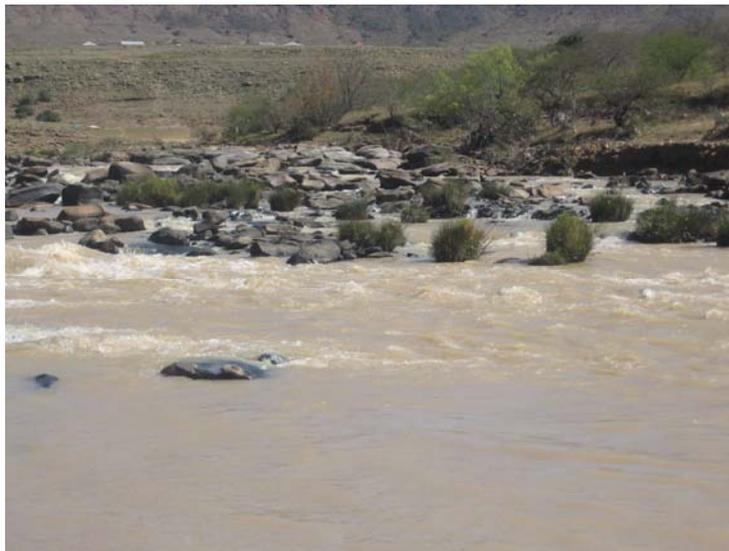
The river system at a site is a mixed channel, meaning that it consists of diversity of morphological units including boulders, cobbles, gravel, sand and silt although **bedrock** is the most dominant feature. It is a pool-rapid system, where the deep pools can serve as refugia for aquatic fauna during times of stress. Since it consists of runs, riffles and rapids, the river system at a site can be considered as rich in terms of habitat diversity for aquatic invertebrates and fish. In addition, the bars (both instream and lateral) serve as a medium for plant growth, hence instream and marginal vegetation; both as habitat for other aquatic species. However, the river system at that reach experience presence of alien plants, decrease in indigenous vegetation on the riparian zone and impacts of livestock. These combined result in erosion both on the floodbank and on the hillslope. The resultant response on the channel is deposition of sediments. For these reasons, the site area can be considered as moderately modified (C class) due to changes in natural habitat although basic ecosystem functioning appears to be predominantly unchanged.

Fig. 13. Photograph of Site 8 (Mgwali Tora) showing the diversity of biotopes and substrate.

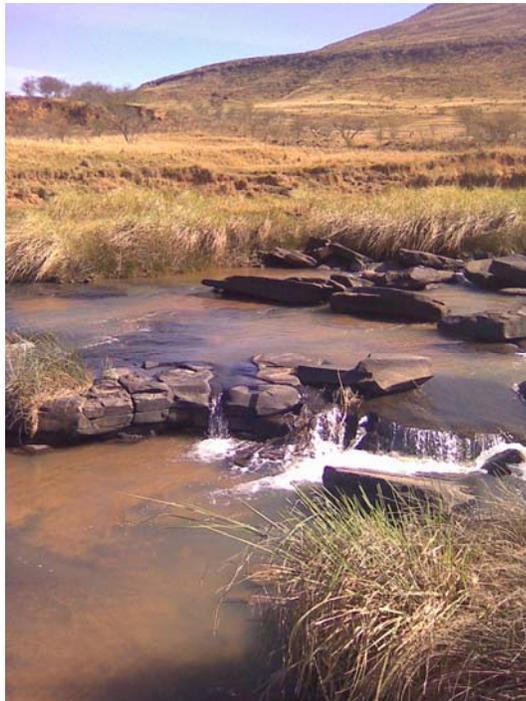
The river at a site area is a meandering structure, where expectations should be alternate erosion and deposition on either side of the channel. The site area is a pool-riffle system and an incised channel. The biotopes consist of side pools, deep pools in the active channel, riffles, a rapid and runs. Mid channel bar and lateral bars with vegetation suggest that although sediment deposition occurs, the river channel is stable hence the vegetation growth occurs. However, the river bank is unstable due to animal trampling causing headcuts and vegetation removal on the riparian zone hence bank erosion with the resultant channel widening and sediment input on the river bed. Hill slopes abutting to the active channel on both the left and the right banks also accelerate sediment input. For these reasons, the site area can be considered as moderately modified (C class) due to changes in natural environment although basic ecosystem functioning appears to be largely unimpacted.

Fig. 14. Photograph of Site 9 (Mgwali Makhobokeni) showing the diversity of biotopes and substrate.

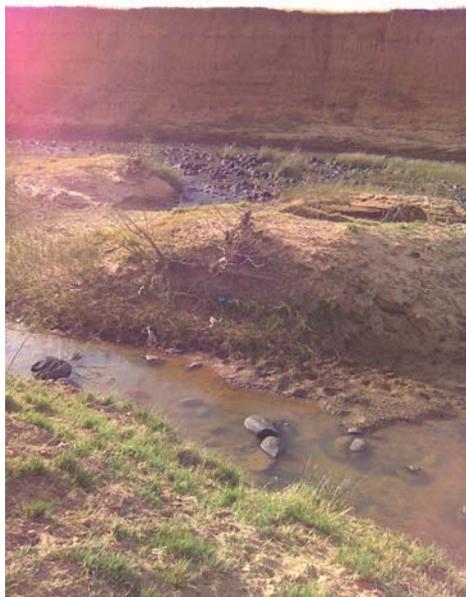
This is a pool-rapid alluvial channel although the riffles, runs and glides could also be observed. These can be regarded as the habitats for diversity of aquatic fauna. The river is sinuous at a reach scale, with a lot of alternative erosion and deposition on both left and a right bank. The tributary at a right bank contributes a lot of fine sediments, probably from the eroded hillslope. The left bank was stable, consisting of bedrock, while the left bank was unstable with fine sediment and sparse vegetation. Mid channel and side bars consisted of cobbles, gravel, sand and silt, with vegetation (mainly shrubs, grass and sedges). Indigenous vegetation was sparse and negligible alien plants and livestock step on. The most problematic practice at a site was sediment mining, which was abundant, upstream of the site. This, together with animal trampling and vegetation removal could play a major role as sources of sediment hence observation of bars downstream. Since the modifications at that time were at a small number of localities (few livestock, sediment mining) and the impact of habitat quality and diversity were fairly limited, the river at a site could be judged as at a moderately impacted (C class).

Fig. 15. Photograph of Site 10 (Mbashe N2) showing the diversity of biotopes and substrate.

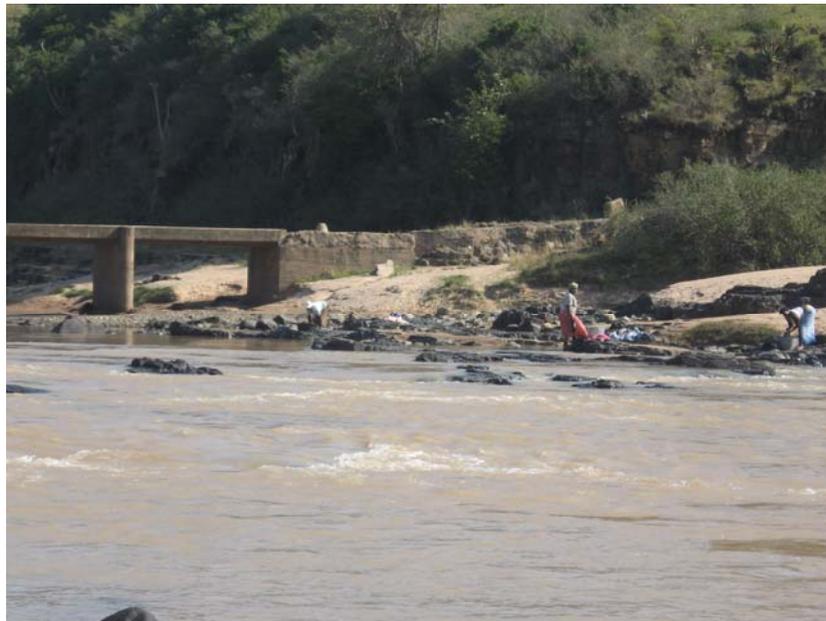
The site is located at a pool-riffle river system and is an alluvial channel. It is a sinuous meandering system where alternative erosion and deposition is expected on both the left and the right bank. The right and a left bank are stabilized by grass (mainly *Cynodom dactylon*). Due to the fact that the river at a site is at a lower foothill, sand bars, deep pools and riffles were evident. The bridge, alien invasive plants, livestock trampling, sediment mining, footpaths and subsistence crop production could have negative impact on physical environment on the river system. Because these occur locally, the river at the site is moderately modified (therefore C category), that is, there is a decrease in natural habitat although basic ecosystem functioning is predominantly unchanged.

Fig. 16. Photograph of Site 11 (Mbashe Mpozolo) showing the diversity of biotopes and substrate.
