ASSESSMENT OF THE GROOT RIVER, MEIRINGSPOORT FOLLOWING DIESEL CONTAMINATION

FINAL REPORT

Prepared by
Justine Ewart-Smith
November 2017

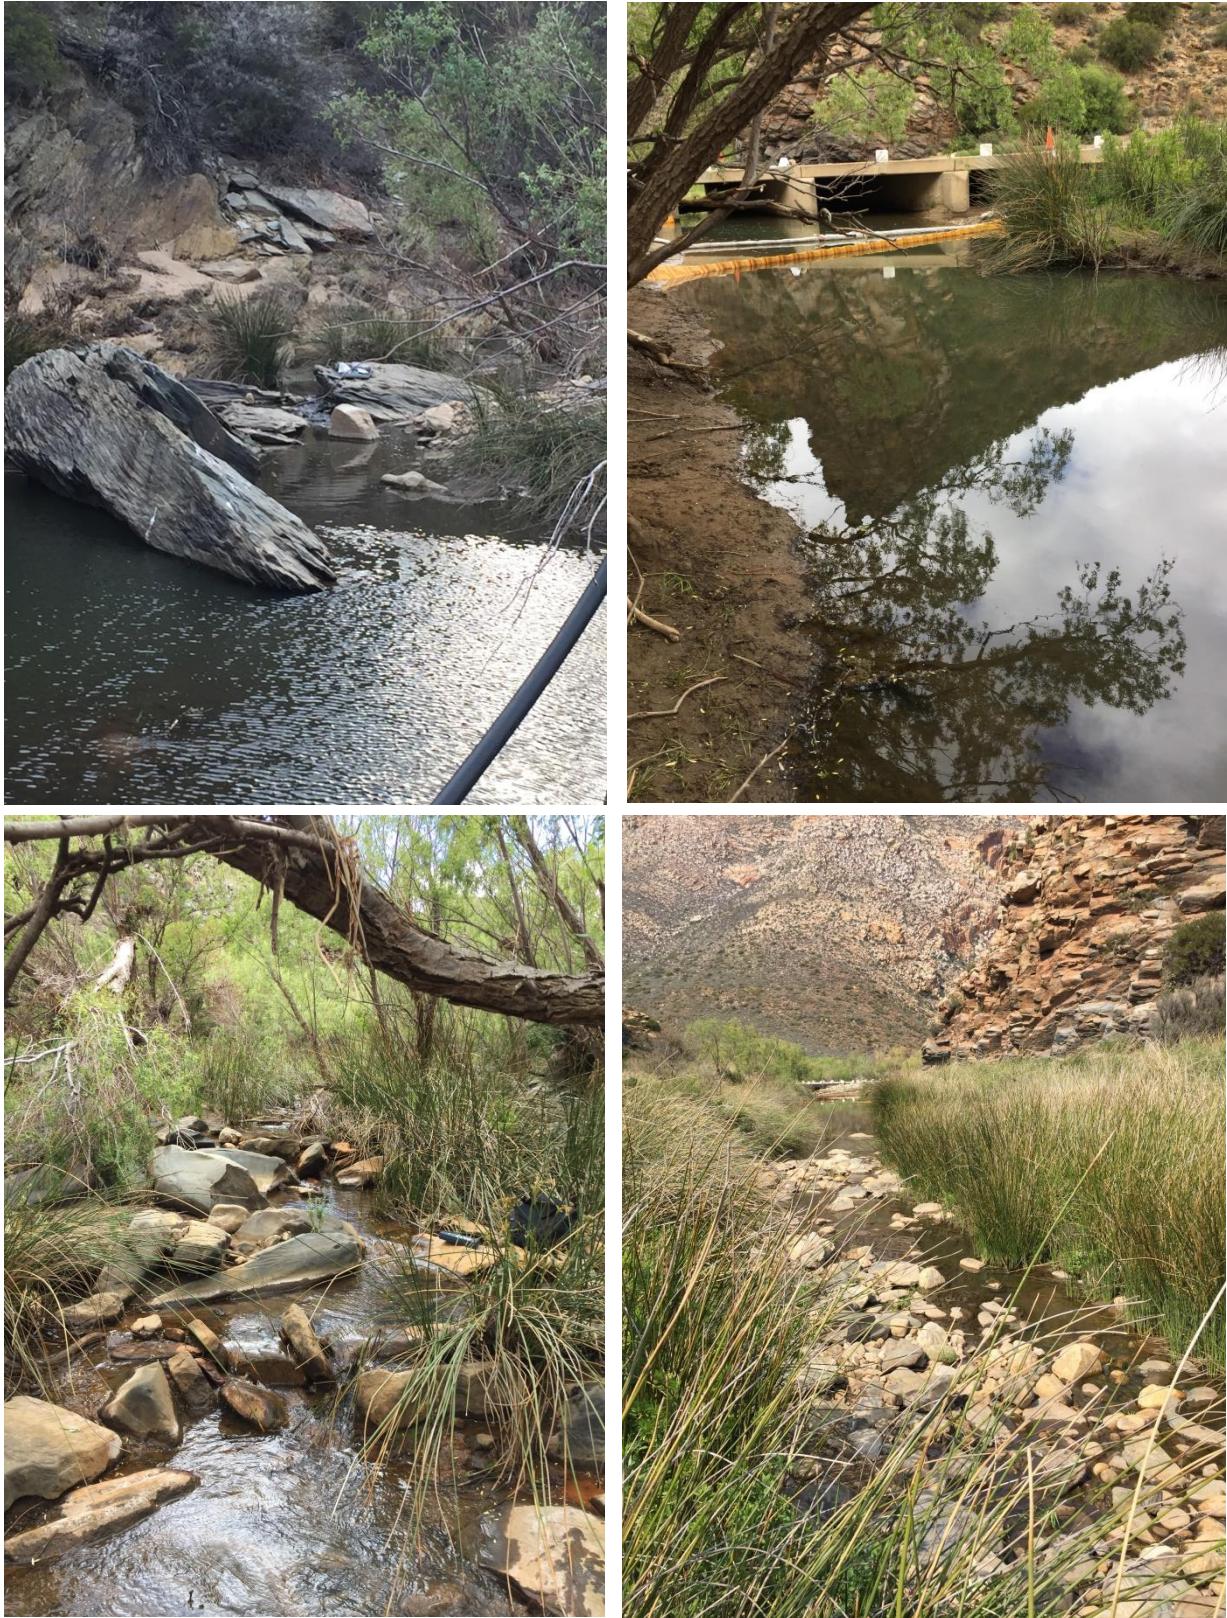
Figure 4.2 a) Site 1 at Middelwater looking upstream from the pool showing predominantly shale bedrock with small gravel and cobble runs and riffles b) Site 2 (i) the pool immediately downstream of the diesel entry point. c) Site 2 at the Spiltech camp looking upstream showing the active channel dominated by boulders and large cobble with the wet bank dominated by the sedge (*Pseudoschoenus* sp.). d) Site 3 looking downstream towards Derde Tol Drif showing the active channel dominated with large cobble runs and riffles and densely vegetated wet banks.

During October 2017, water quality data was collected from all 5 of these sites , as well as from the point of enter of the Diesel spill because BioSolve® was applied to the river bank at this point and thus it was necessary to determine if there were any effects on water chemistry immediately downstream of the point of application. This site is referred to as **Site 2(i): Diesel Entry**. These sites are illustrated in Figure 4.2.

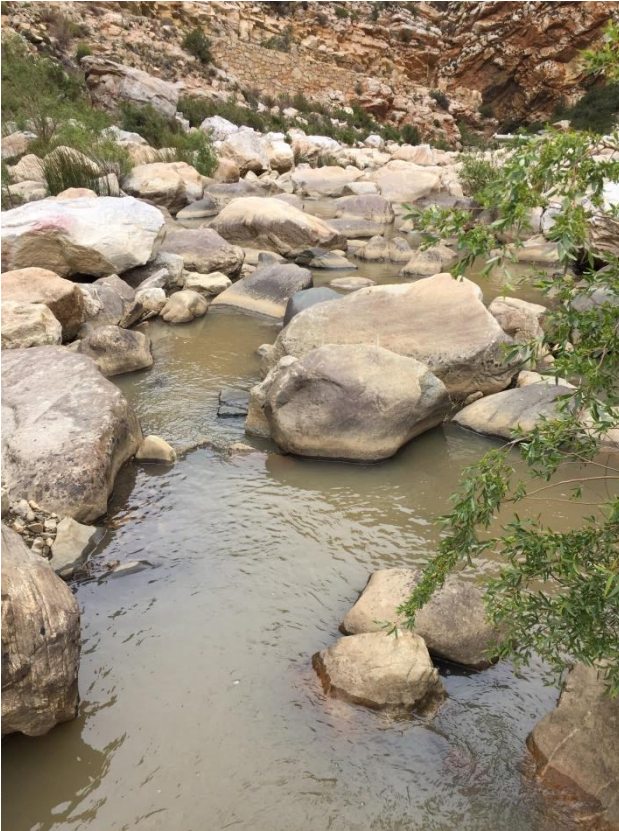
Figure 4.2 continued e) Site 4 immediately upstream of Ontploffings Drif showing the active channel dominated by large sandstone derived boulders and bedrock. High turbidity is associated with bridge maintenance activities at the time of the site visit in October 2017. F) Site 5 at Alwyns Drif showing the active channel dominated by sandstone derived cobbles and boulders with a riparian fringe dominated by *Salix mucronata*.

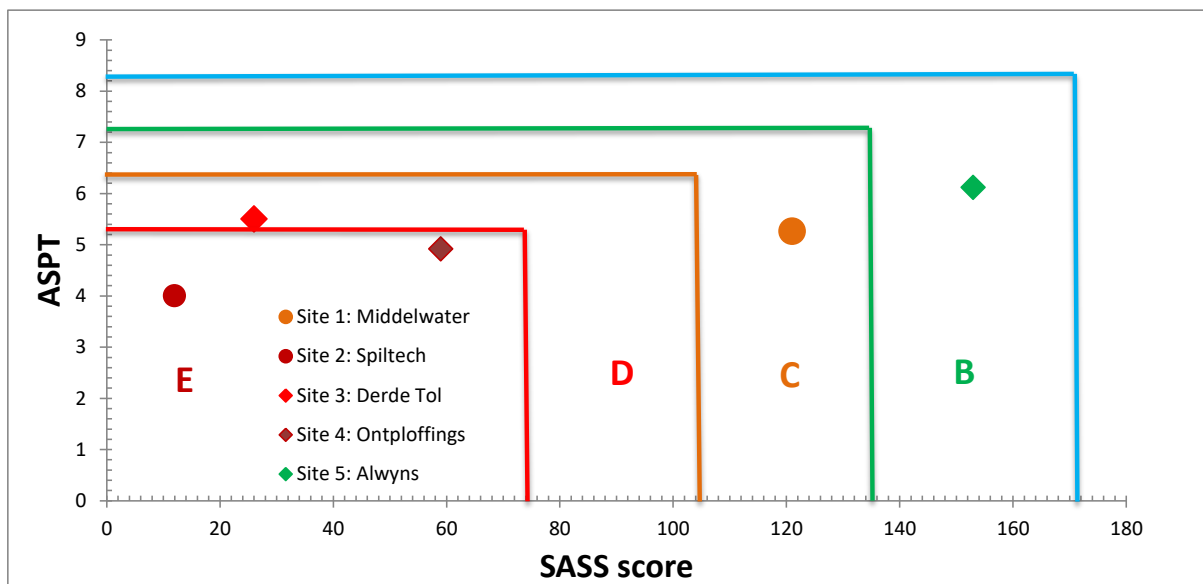
Figure 5.4 SASS scores and ASPT values at biomonitoring sites on the Meirings River. The biological bands depicting change in condition are taken from Dallas (2007).

Upstream of the diesel spill (i.e. Site 1: Middelwater), the Meirings River is rated as a Class C (Table 5.6), based on the overall SASS and ASPT score in September 2017 (Figure 5.4), thus reflecting a system that is moderately modified with a loss of most pollution sensitive taxa (Table 5.7). Impairment at this site is largely a consequence of water quality impacts, probably due to farming activities upstream. The condition of the system deteriorates considerably however with a SASS and ASPT score near the spill entry site (i.e. Site 2: Spiltech) reflecting a Class E/F (Figure 5.4). Essentially, very few invertebrates were present at the time of the site visit, with those surviving taxa known to be hardy and pollution tolerant. Taxa included adult Dytiscid beetles which are air breathers and relatively mobile. It is likely that the few individuals present at the time of the site visit had colonised since the spill event. The only other invertebrates present were 2 tabanid (horsefly) larvae and 2 chironomid (midge) larvae (Table 5.8).

Conditions at the downstream extent of the impact zone (i.e. Site 3: Derde Tol Drif) were slightly improved with a SASS and ASPT score reflecting a Class D condition in terms of the macroinvertebrate condition (Table 5.6). Nevertheless, the invertebrate community at this site was still severely impaired with a dominance of airbreathing taxa that are likely to have recolonised since the spill event. These include the hemiptera, corixidae and naucoridae as well as dytiscid and gyrrinid beetles, mostly within the marginal vegetation. Other taxa include hardy fly larvae such as chironomids, ceratopogonids and ephydriids. However, unlike the Spiltech site, other more sensitive taxa including 1 individual of the family Athericidae, as well as 2 elmid beetle larvae were present at this site (Table 5.9), suggesting that the impact was less severe with distance from the spill entry site.

Surprisingly, a further 800 m downstream of the impact zone at Site 4 (i.e. Ontploffings Drif), the macroinvertebrate community sampled in September 2017 was severely impacted with a SASS and ASPT score reflecting a Class E/F (Figure 5.4 and Table 5.6). While there was no visual evidence of contamination at this site, with in situ physico-chemistry indicative of unimpacted conditions (see Table 5.4), these data suggest that the impact of the diesel spill extended well below the so-called impact zone. Unfortunately, no water chemistry samples were collected at this site but the slightly elevated COD and TOG concentrations measured at this site in October 2017 further suggest that the impacts of the spill extended a considerable distance downstream of the entry point. Once again, the community was dominated by airbreathers within the order hemiptera (true bugs) and coleoptera (beetles) (Table 5.10).

The macroinvertebrate community a further 8.5 km downstream of the impact zone at Site 5 (Alwyns Drif) suggests that the diesel spill had no apparent impact on this reach of the river. The SASS and ASPT scores reflect a Class B condition (Figure 5.4), indicative of an ecosystem that is in good condition (Table 5.6). Indeed, sensitive taxa, including at least three species of mayfly larvae (baetidae) and leptophlebidae were present, together with trichoptera (Table 5.11). Other sensitive taxa included the riffle beetle larvae, Elmidae, the dragonfly larvae, aeshnidae and the sensitive true fly larvae, Dixidae (Table 5.11).
