**NEMA SECTION 24 G RECTIFICATION APPLICATION FOR A WEIR
AND PIPELINE ON FARM 781, BOTRIVIER**

SPECIALIST REPORT: AQUATIC ECOSYSTEMS

November 2017

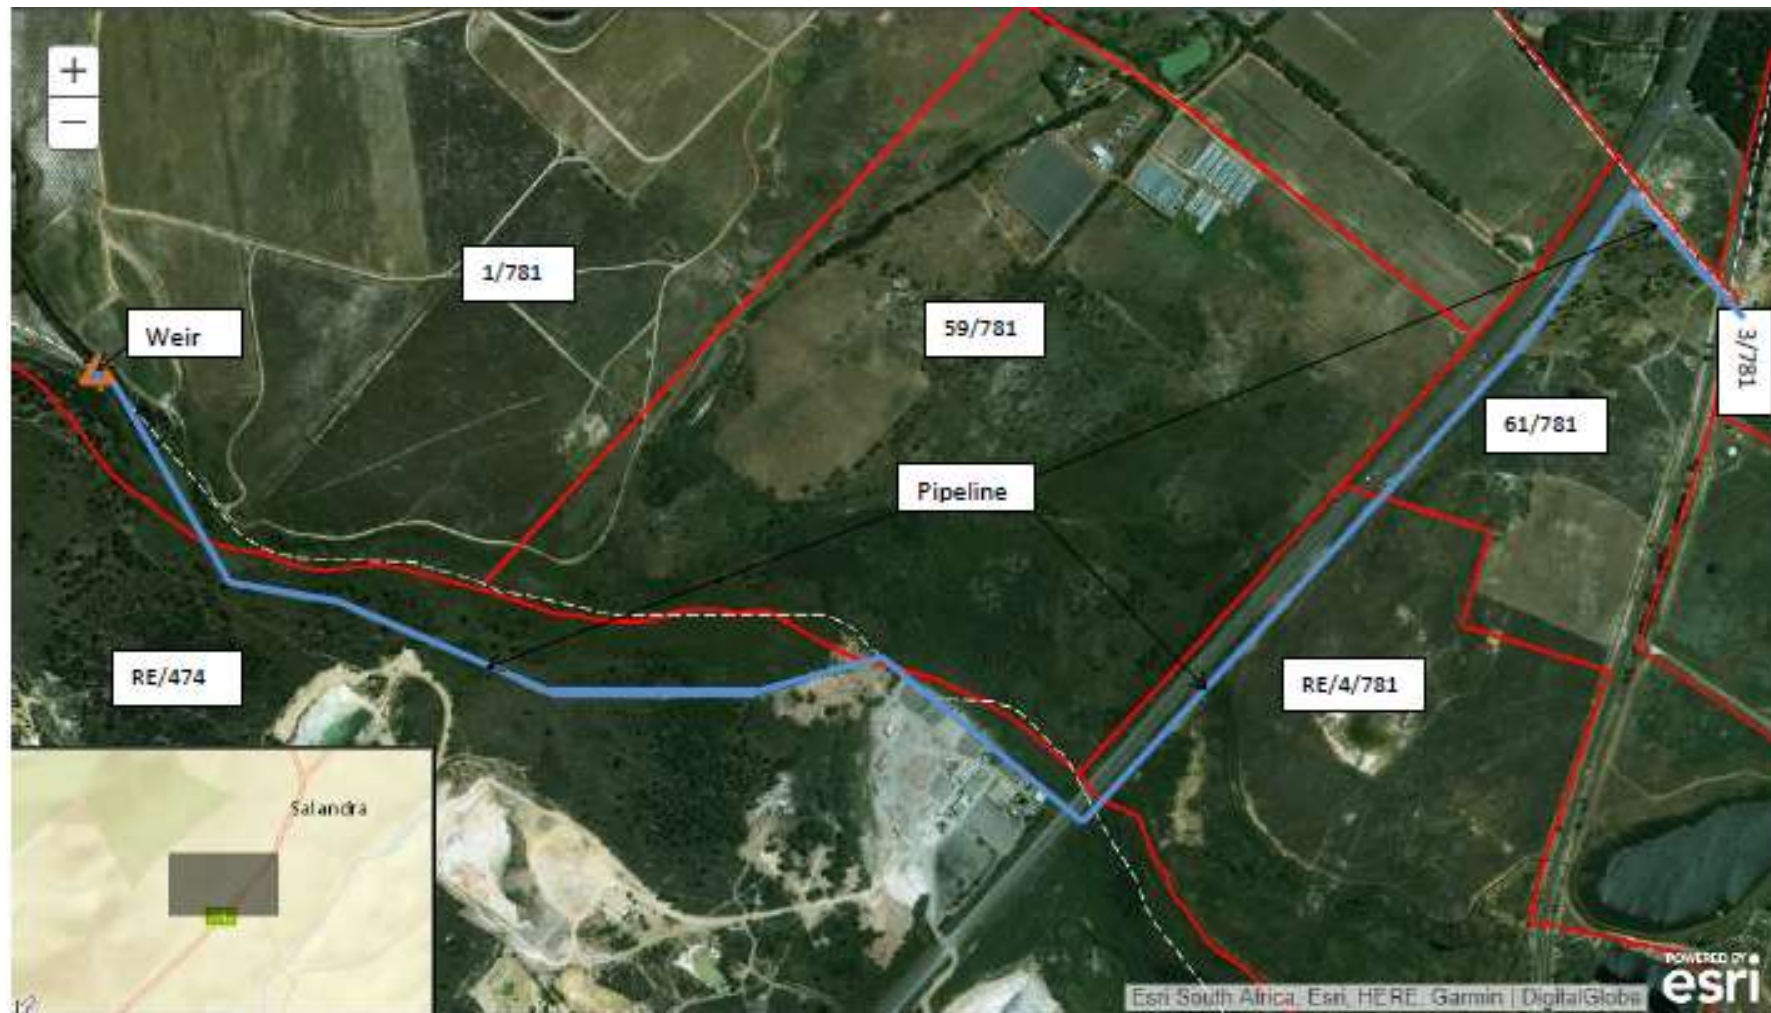
Figure 1.2 The Study Area showing the location of the weir and pipeline route (blue). The relevant property boundaries are shown in red (source: Cape Farm Mapper).

The study area extends over several properties, including Farm 1/781, RE/474, RE/4/781, 59/781, RE/4/781 and 3/781 which straddle the R43 between the town of Bot River about 4.5 km north and Hermanus to the South (Figure 1.1 and Figure 1.2). The weir and pipeline are situation within or adjacent to the channel and wetlands of the Huiskloof River (Figure 1.2), which confluences with the Bot River in its lower reaches before it reaches the Bot River Estuary (Figure 1.1).

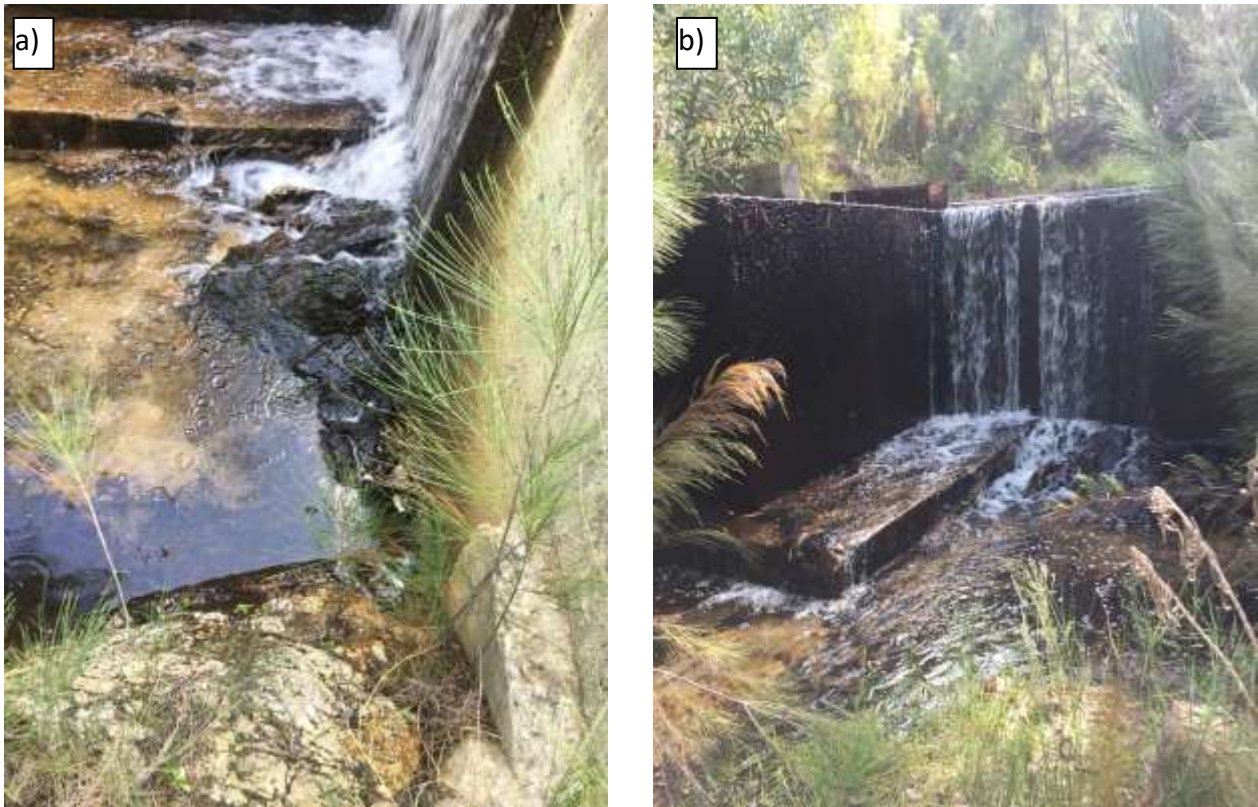
Figure 3.2 The weir constructed on the Huiskloof River in 2010 a) showing the bedrock outcrop on which the weir is situated thus minimising the risk of erosion an b) looking upstream from the active channel

The weir consists of a wall about 1.7 m in height from the base at the downstream side of the weir (Figure 3.2a and Figure 3.3). The width of the wall is about 5 m from the left bank with an overflow of about 1.5 m wide in the centre of the active channel. Beyond the active channel is a concrete pool that houses the offtake pipe for the diversion of runoff from the channel. At the base of the weir wall is a concrete shelf approximately 2 m wide from the wall which acts as scour protection immediately downstream of the structure. The approximate dimensions of the structure are shown in Figure 3.3.

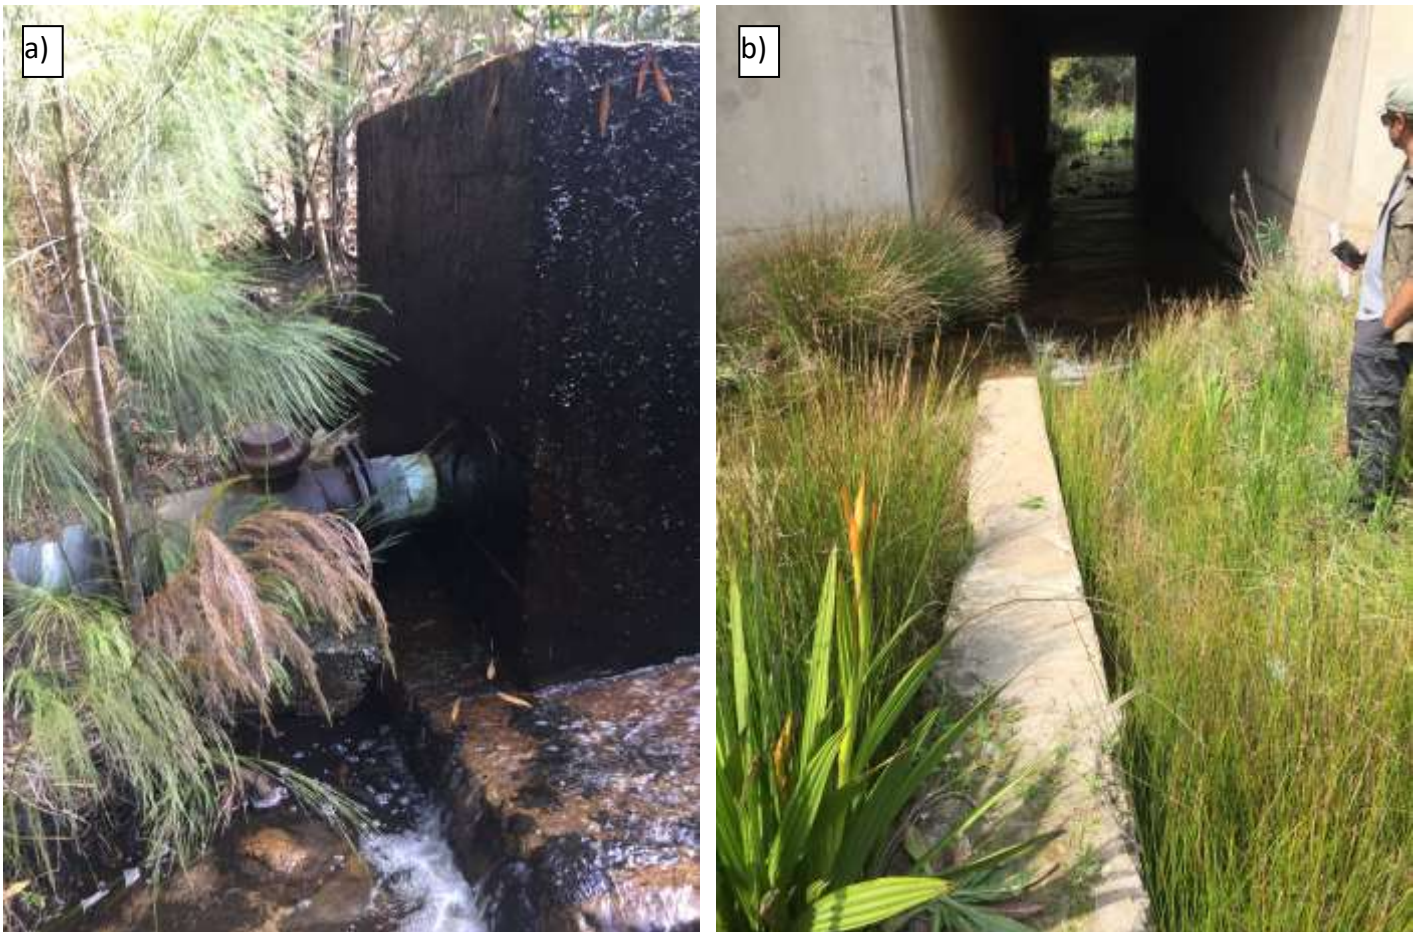
Figure 3.4 The 200mm diameter pipeline extends from a) the pool structure associated with the weir for diversion of runoff from the Huiskloof River and b) then crosses the active channel of from Huiskloof River immediately upstream of the culvert below the R43.

The pipeline carrying diverted runoff from the Huiskloof River to Farm 3/781 is 200 mm in diameter. The pipeline leads from the weir structure (Figure 3.4a) towards the upper slopes along the left (southern) bank of the Huiskloof River. It largely extends beyond the riparian edge of the Huiskloof River until it reaches the quarry near the R43. Here the quarry encroaches into wetland habitat and the pipeline route abuts the outer edge of the quarry until it reaches the R43 (Figure 3.1). At this point, the pipe crosses the active channel of the Huiskloof River within a concrete structure (Figure 3.4b). On the downstream end of the culvert below the R43, the pipeline route heads away from the channel until it reaches a storage dam on Farm 3/781 (Figure 3.1). The total length of the pipeline route is approximately 3km from the weir on the Huiskloof River the storage dam on Farm 3/781.

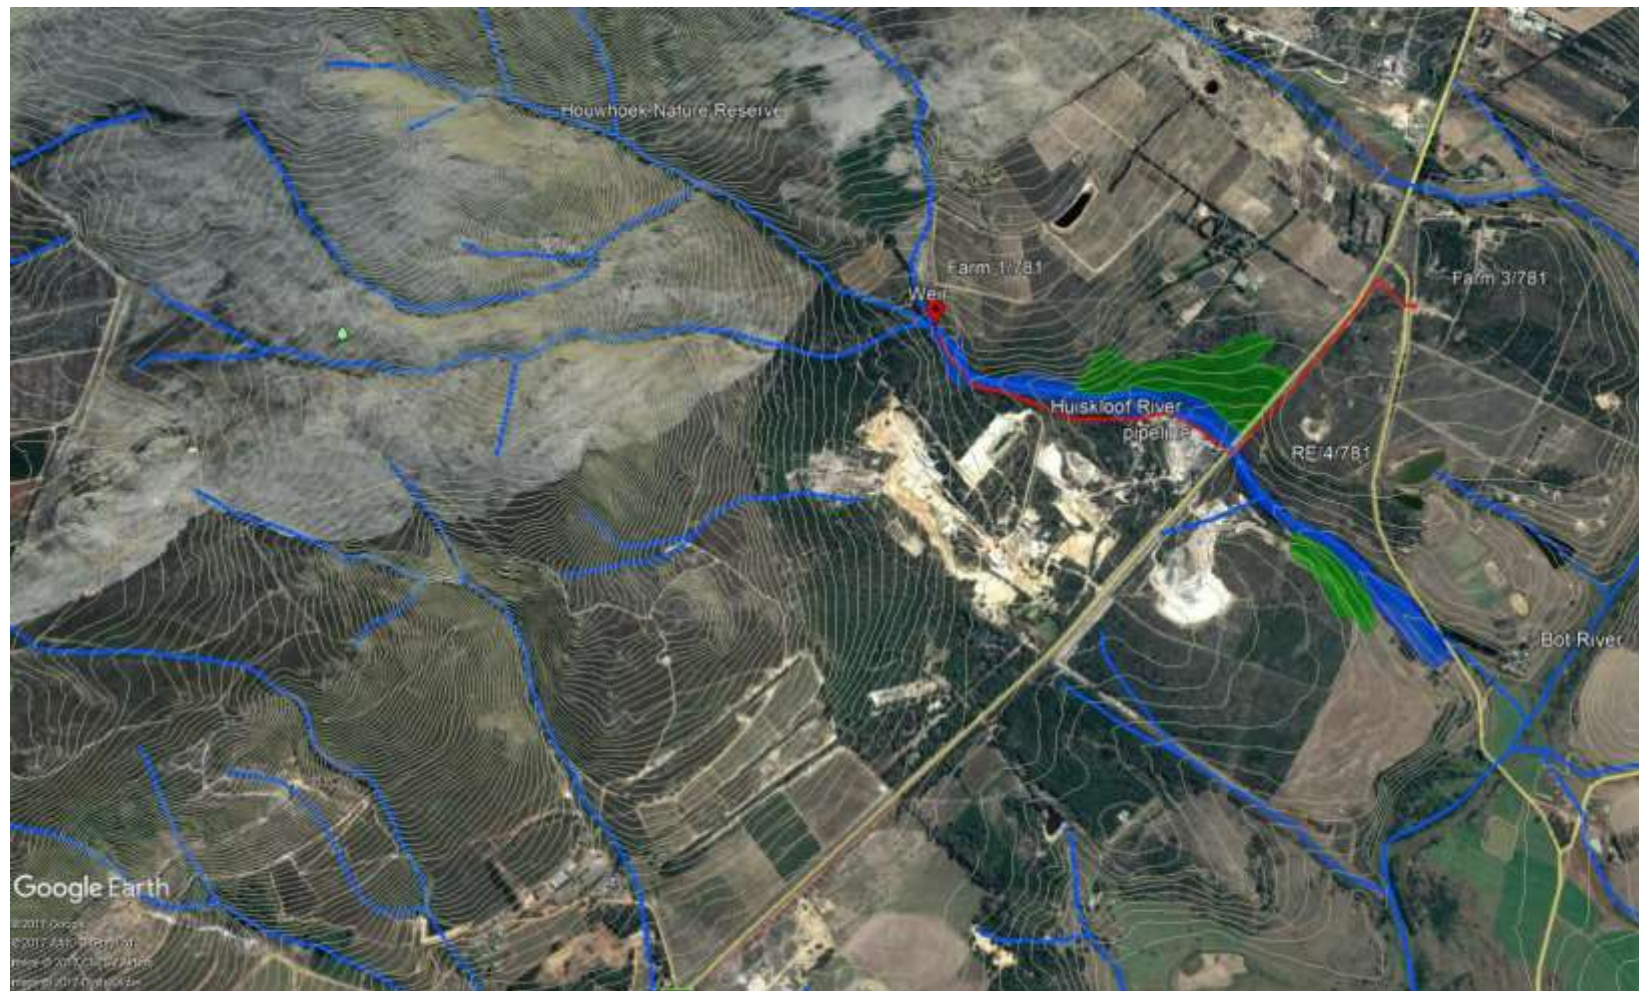
Figure 4.1 The Huiskloof River catchment showing the three upper tributaries that rise in the Houwhoek Nature Reserve and merge within Farm 1/781 to form the Huiskloof River which continues as a channelled valley bottom wetland (Blue area) fed by seep wetlands (green area).

The Huiskloof River rises in the Kogelberg (Houwhoek) Nature Reserve as three tributaries that flow in a south easterly direction through a largely natural landscape (Figure 4.1). Within the foothills, these tributaries enter farmlands dominated by vineyards where they merge to form the Huiskloof River. Downstream of this point, the slope flattens and the river flows for about 1.7 km as a broad, Channelled Valley Bottom Wetland fed by a seep from the north until it reaches the R43 where all flow is directed below the road via a relatively narrow culvert. The Huiskloof River downstream of the R43 continues as a narrow channel (about 1.5 m wide) flanked by wetland habitat that is hydrologically isolated from the channel, heavily invaded by alien trees and is thus no longer functional wetland habitat. Approximately 1.5 km for the R43, the Huiskloof River joins the Bot River. From immediately upstream of the point at which the foothill tributaries merge to form the Huiskloof River, to its confluence with the Bot River, this system is surrounded by cultivated lands with a number of quarries that impact variously on the river itself.

The pipe passes through a section of the marginal fringe of the valley bottom wetland immediately downstream of the weir (Figure 4.1) and then follows the channel on its right bank, until reaches the R43. Then it crosses the channel within a concrete structure (Figure 3.4b), passing through the remnants of Valley Bottom wetland adjacent to the active channel downstream before heading away from the river altogether. Construction of the pipeline would have resulted in **disturbance of wetland habitat** during construction activities. These construction phase impacts were likely of low intensity and endured in the short to medium term resulting in impacts of **low significance** (Table 5.1)

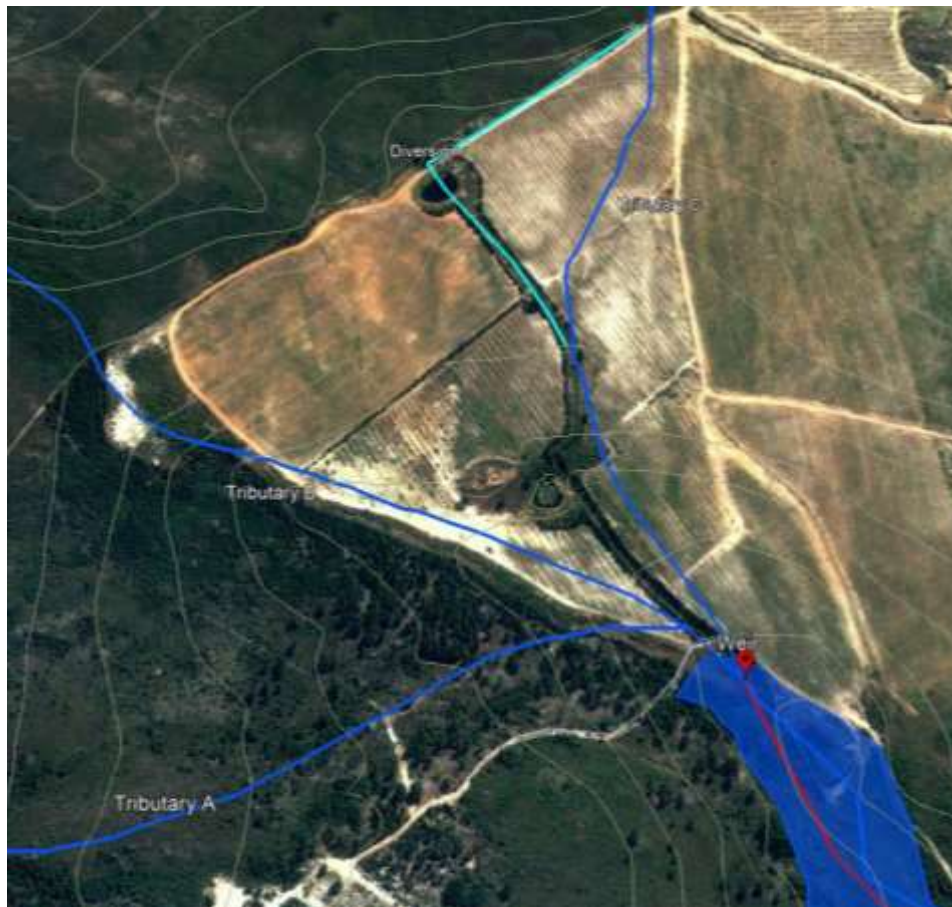
Figure 4.4 The three tributaries which form the Huiskloof River as they flow through Farm 1/781

Three tributaries labelled Tributary A, B and C in Figure 4.4 merge immediately upstream of the weir to form the Huiskloof River. The southernmost tributary (Tributary A) flows predominantly through alien trees such as pines. Immediately upstream of its confluence with Tributary B, it flows as a narrow, sandy stream with occasional cobbles through dense pines. Green filamentous algae suggests that the system may be enriched with little or no natural features.

The northern most tributary (Tributary C) has been diverted to maximise areas for cultivation and is impeded by 2 instream dams and an offtake at the point of diversion. Most of the riparian fringe has been lost to accommodate farming in the immediate surrounds and the little remaining vegetation along this channel consists of a few sedges but mostly alien trees, particularly Beef woods (*Pinus sp.*) (Figure 4.5). The channel passes via pipes below a small dirt road crossing the river and merges with Tributary B immediately upstream of the weir.

Tributary B (Figure 4.4) is the main channel that contributes to the flow of the Huiskloof River. Similar to Tributary C, this system has been impacted by loss of riparian and instream habitat, although flows are not as severely impacted. The riparian fringe for most of its length is dominated by beef wood trees that have excluded almost all natural vegetation resulting in a largely sterile channel (Figure 4.6). Naturally this system would have been characterised as a transitional river with features of both mountain streams and foothill cobble-bed rivers. Although some bedrock steps provide some habitat, sedimentation due to loss of riparian vegetation is excessive (Figure 4.6). However, the system recovers somewhat immediately upstream of the point where it merges with the other two tributaries. Here, the channel margin is dominated by indigenous vegetation typical of transitional Fynbos streams, including *Calopsis paniculata*, *Prionium seratum* (Palmiet), *Osmatopsis sp.* and *Psoralea pinnata* either side of a narrow cobble and bedrock channel.

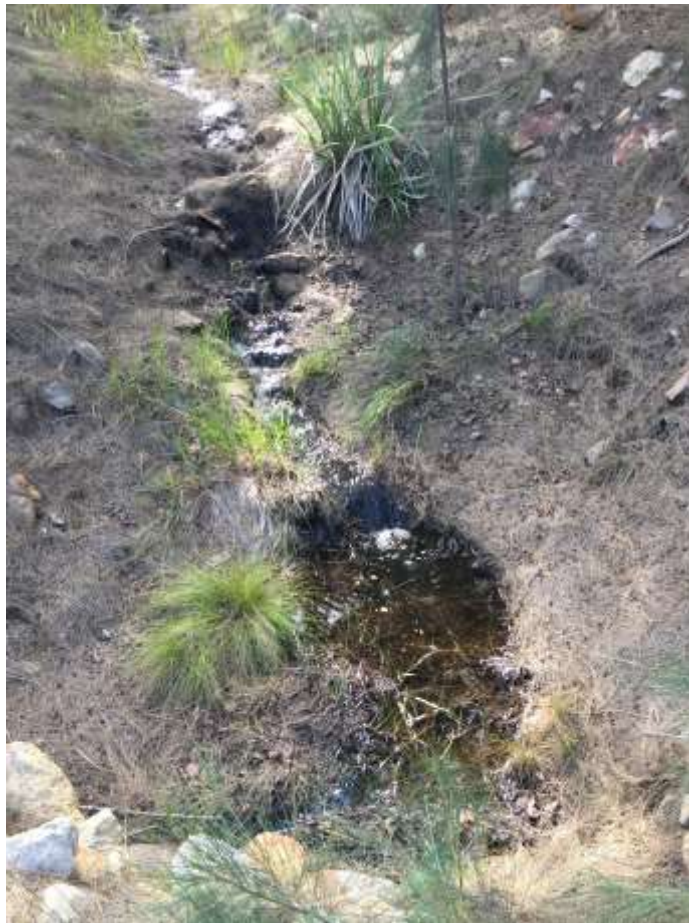
Figure 4.5 Tributary C immediately upstream of its confluence with the Huiskloof River. This stream is severely impacted by surrounding agricultural activities, loss of natural riparian vegetation, loss of instream habitat and change in low flows due to abstraction and the presence of two instream farm dams.

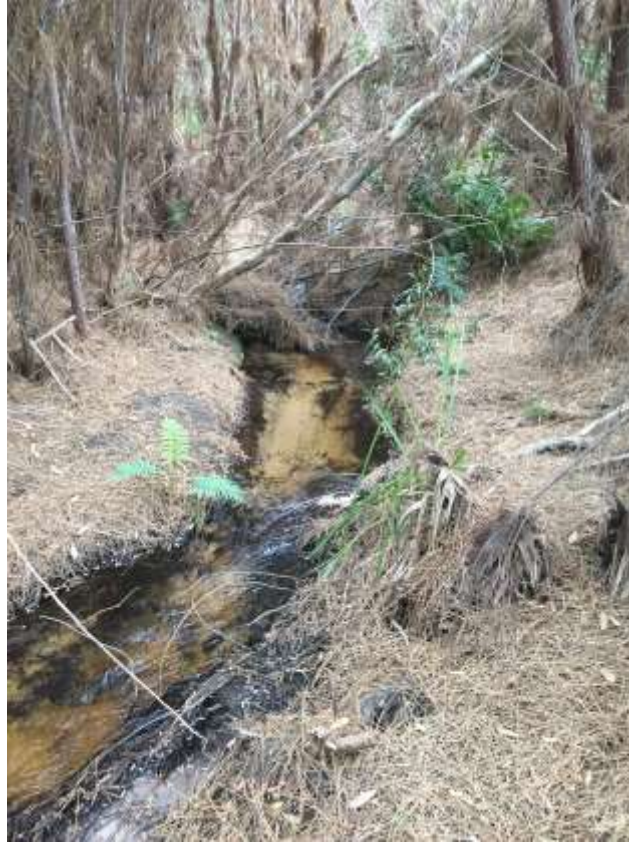
Figure 4.6 Tributary B downstream of the Houwhoek Nature Reserve where it has lost most of its instream and riparian habitat as its flows through dense alien trees alongside a gravel road that impinges on riparian fringe.

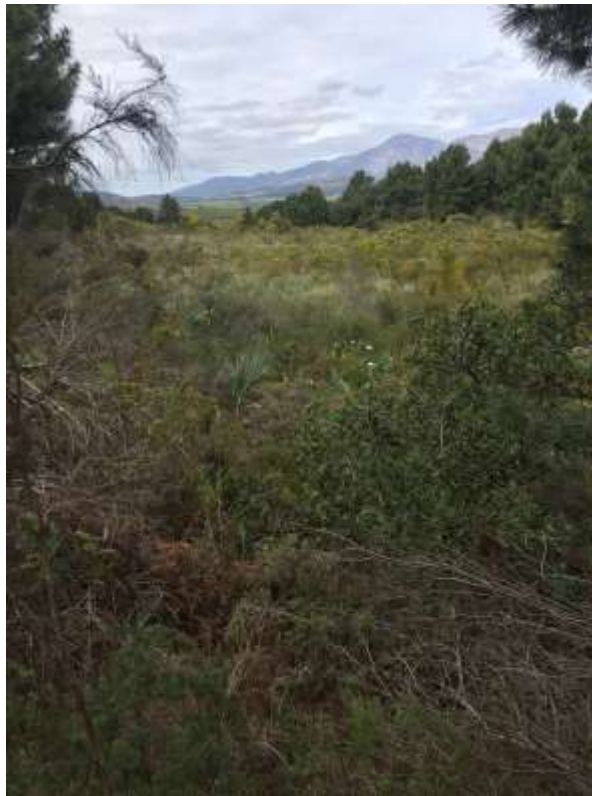
Figure 4.7 The Channelled-Valley Bottom wetland characteristic of the Huiskloof River immediately downstream of the weir. While the wetland is dominated by a diversity of indigenous plant species, the dry margins are dominated by alien invasive trees.

Downstream of the weir constructed in 2010, the slope of the Huis River flattens somewhat and widens into a Channelled-Valley Bottom wetland with multiple channels that support dense stands of Palmiet (*Prionium serratum*) together with the tall white daisy (*Osmatopsis sp.*) and the Erica, *Calopsis paniculata* in the wetter areas. Along the drier margins, the channel characterised by *Berzelia sp.*, together with *Pteridium aquilinum* and stands of *Psoralea pinnata* which give way to dense invasion by alien trees, mostly pines (*Pinus sp*) (Figure 4.7). The system at this point is about 50 m wide but increases to about 100 m as it approaches the R43 downstream with a total area of 14.13 ha. Immediately prior to entering the culvert beneath the R43, the active channel is crossed by the pipeline (Figure 3.4b). Under natural conditions, this system would have been fed by the large seep habitat of about 17.42 ha that joins this system along its right bank. However, under present day conditions, this system is bisected by an offtake channel that carries runoff from an old weir near the centre of the system to an off-channel storage facility downstream of the R43. Thus, the abstraction of water at this point as well as changes in the hydrological functioning of the system due to channelization through the seep has altered the natural character of this system.

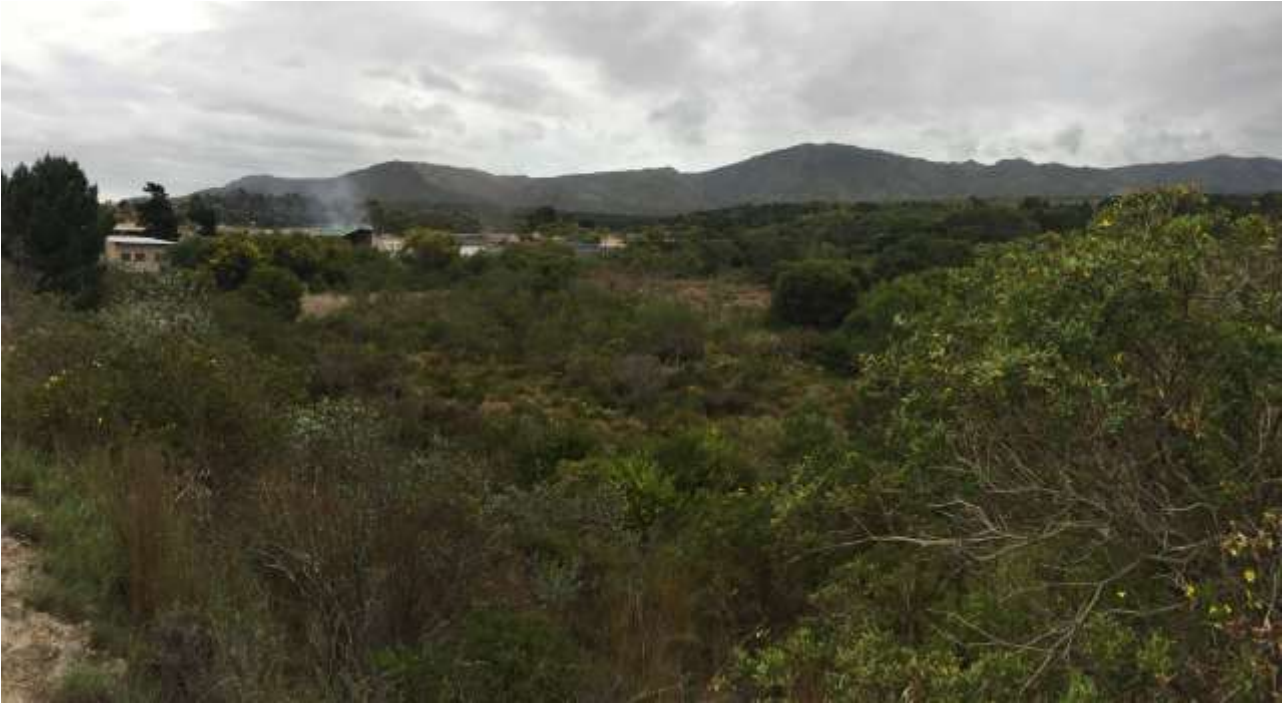
Figure 4.8 The Channelled-Valley Bottom wetland of the Huiskloof River immediately upstream of the R43. The quarry encroaching in the wetland habitat is evident along the right bank of the river (to the left of the picture).

Near the R43, the main channel is situated along the right bank and is dominated by *Typha capensis*, possibly due to poor quality runoff from the adjacent quarry which may promote the proliferation of this species. Despite these surrounding impacts to the wetland and changes in its hydrogeomorphological character associate with abstraction and diversion of flows, the remaining valley bottom habitat is dominated by a diversity of indigenous plants including *Wachendorfia thyrsoiflora*, patches of sedges such as *Scirpus nodosa* and *Juncus kraussi* with *Calopis paniculata* *Osmatopsis sp.*, *Pteridium aquilinum* and the wetland grass, *Pennisetum macrurum* (Figure 4.8). However, invasion by alien trees such as *Acacia sp.* and *Pinus sp.* is more prolific downstream of the old abstraction weir.

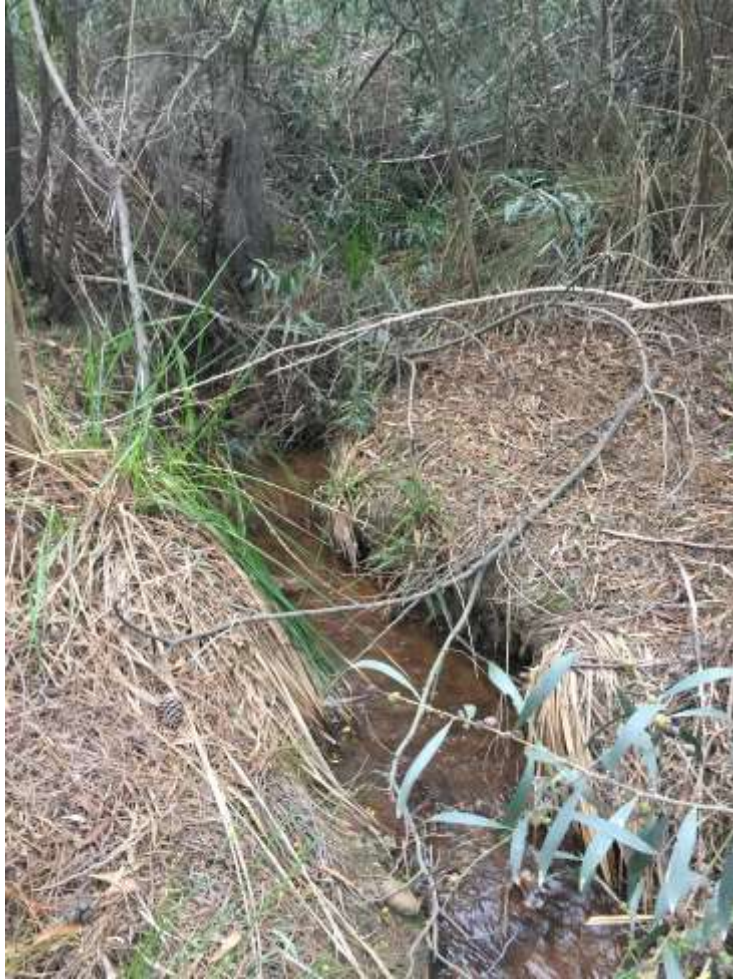
Figure 4.9 The Huiskloof River downstream of the R43 is characterised as a narrow channel hydrologically isolated from the wetland habitat that would naturally surrounded this system. The remnant valley bottom component is heavily invaded with alien trees (*Acacia* sp.).

The Huis River passes the R43 through a culvert about 5 m wide and thus the naturally broad wetland habitat becomes confined to a narrow channel that is separated from the surrounding wetland through down-cutting of the channel bed (Figure 4.9). The once functional valley bottom wetland habitat is now heavily infested with alien trees, mainly *Acacia sp.* and *Pinus sp.* It is likely that only the biggest floods inundate the once extensive Valley bottom and thus is now largely dry supporting few wetland functions. This system is about 9 ha in area but there are a number of dams that encroach into the valley bottom on the right bank between a quarry and the river system.

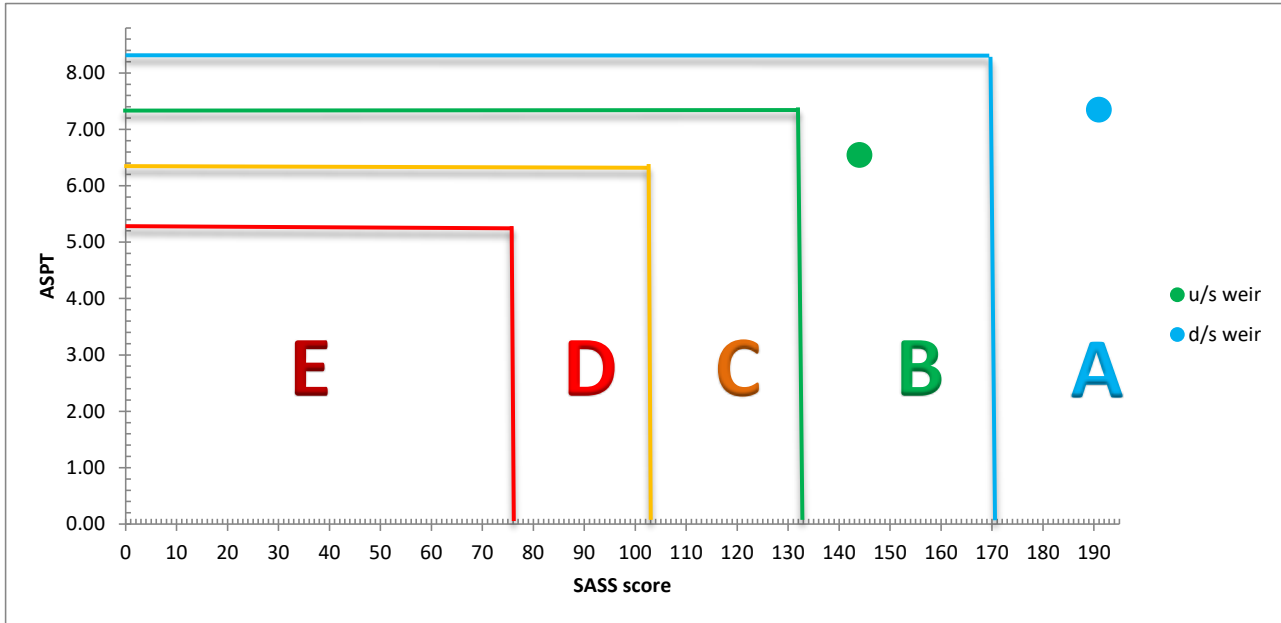
Figure 4.10 Biological bands (after Dallas 2007) depicting condition in terms of macroinvertebrate communities upstream and downstream of the weir on the Huiskloof River.

Site	SASS score	Total number of families	ASPT	Category
Upstream of weir	144	22	6.66	B
Downstream of weir	191	26	7.35	A

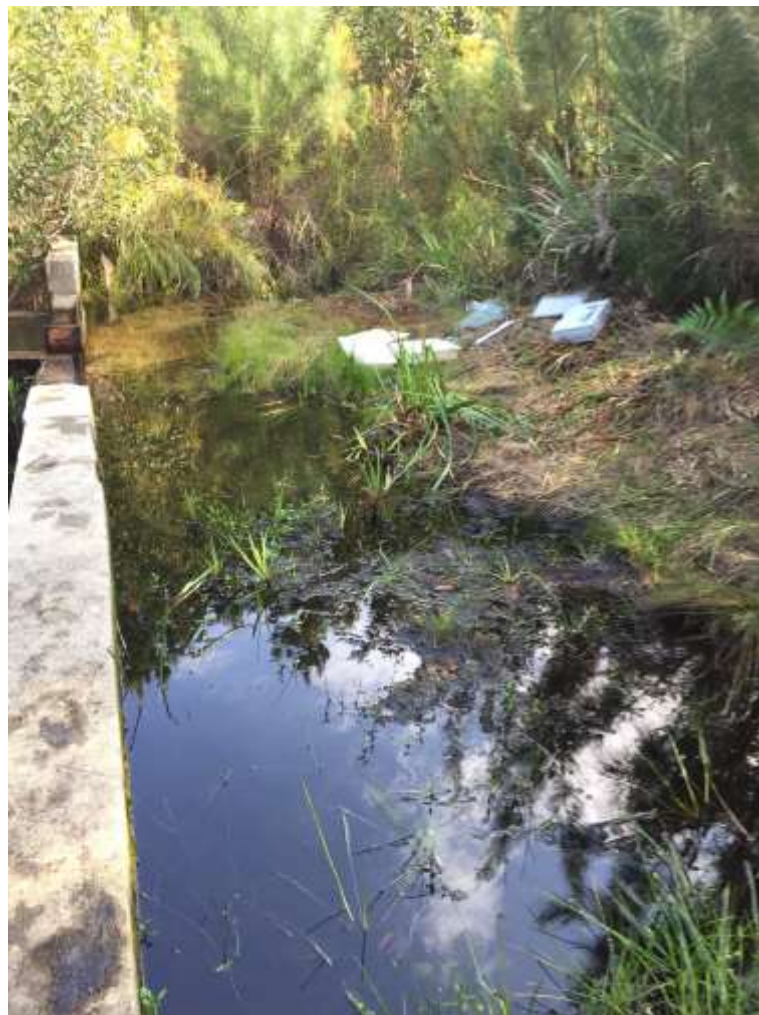
Nevertheless, the structure does lead to ponding and ***inundation of the upstream channel*** where sediments have settled out (Figure 5.1). Thus, inundation of the active channel has resulted in a change in habitat from fast flowing riffles and runs over stones to standing water over fine silt which has promoted the proliferation of instream vegetation (mostly *Juncus sp.*). Besides the loss of habitat associated with inundation, if not adequately cleared on a regular basis, such vegetation could result in the diversion of flood flows around the structure which could lead to structure failure and associated impacts. While the risk of structure failure associated with vegetation proliferation is easily prevented through routine channel clearance, the loss of instream habitat associated with inundation is a negative impact that is local in extent and of low intensity. Also, habitat loss is limited to the site of the weir but will persist in the long term. It is therefore considered a ***negative impact of low significance*** (Table 5.1).

Figure 5.1 Inundation upstream of the weir has resulted in habitat change with the proliferation of *Juncus sp.* that has been recently removed from the ponded habitat and placed on the riparian margin between the two channels that confluence at this point. In this picture, sampling material is situated on top of the recently removed *Juncus sp.* plant material.

This should be undertaken at the end of the dry season each year before the onset of winter rains. This will reduce the risk of diversion of flood flows that could lead to structure failure. However, removal should be undertaken by hand, taking care to minimise disturbance of the remaining in-channel habitat and riparian fringe. Also, vegetation removed from standing water should be disposed of outside of the river and its riparian fringe to prevent flushing of material into the valley bottom wetland downstream.

Also, inundation of the channel with sediments associated with periodic discharge from the pipeline is associated with impacts of high significance to the Huiskloof River. To offset these impact it is recommended that flushing of sediments take place immediately prior to the onset of winter rains each year such that the volume of accumulated sediments is minimised and those that have accumulated over a year are flushed and distributed through the system. This will minimise the intensity of the impact and prevent accumulation of sediments and associated loss of habitat and geomorphological changes to the system.
