Client
Envirosure

ASSESSMENT OF THE GROOT RIVER, MEIRINGSPOORT FOLLOWING DIESEL CONTAMINATION

2ND MONITORING REPORT

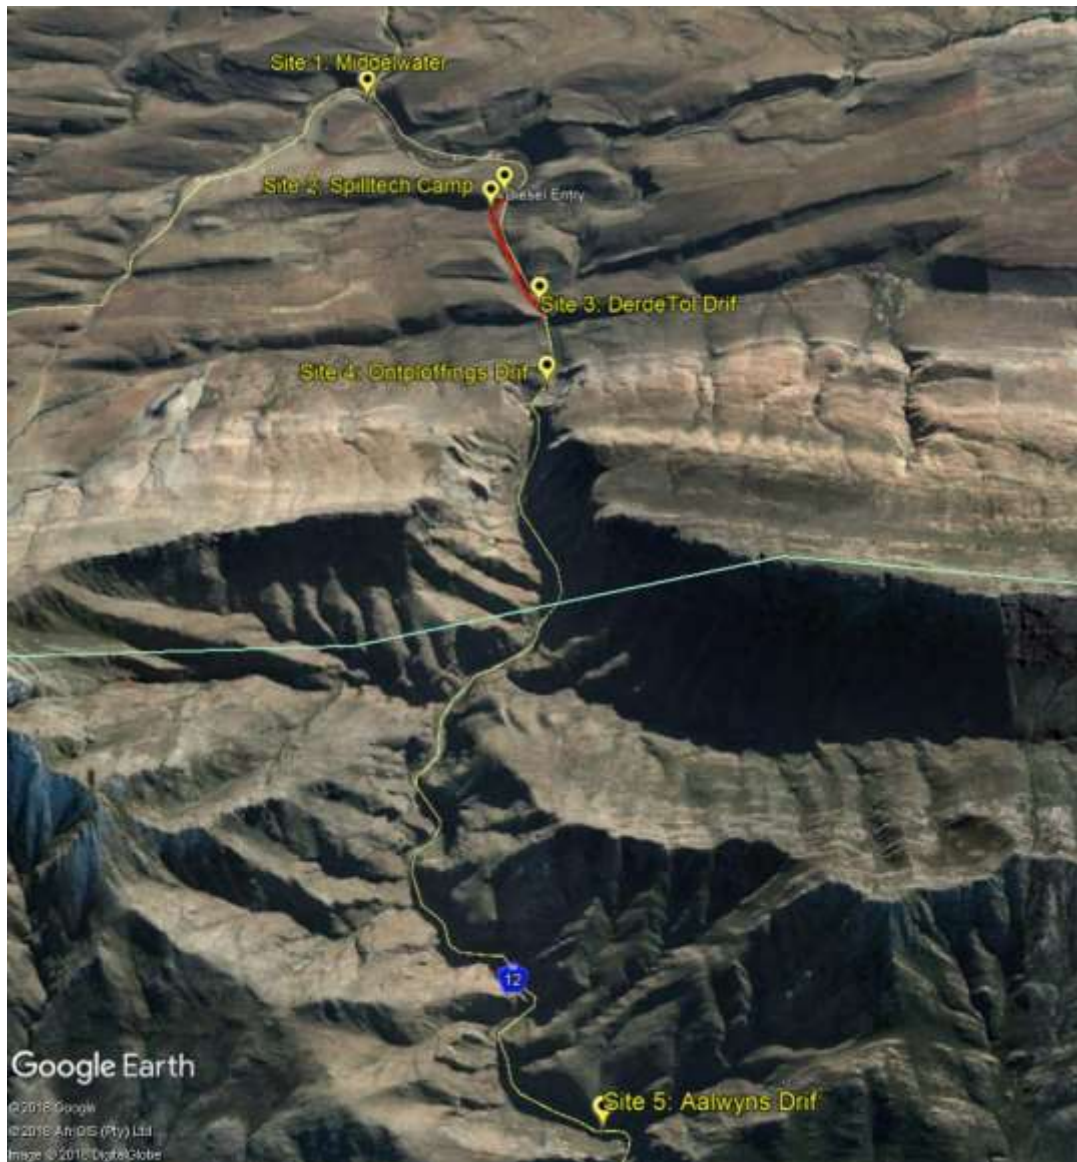
Figure3.1 Location of the 5 monitoring sites on the Groot/Meirings River showing the impact zone (red).

Five monitoring sites (Figure 3.1) were selected as part of the Baseline Survey in September 2017 when water levels and flow in the system provided a diversity of different habitats for aquatic biota. During December 2017, flows were reduced to a slight trickle at Middelwater and Derde Tol Drif while no flow was encountered at Ontploffings Drif. By August 2018, Middelwater, Derde Tol Drif and Ontploffings Drif were completely dry with only standing pools present at the Spiltech Camp site (Figures 3.2 to 3.4). The only site with similar water levels and flow conditions to that encountered in September 2017 was Aalwyn Drif (Figure 3.5). Table 3.1 provides a summary of the available habitats

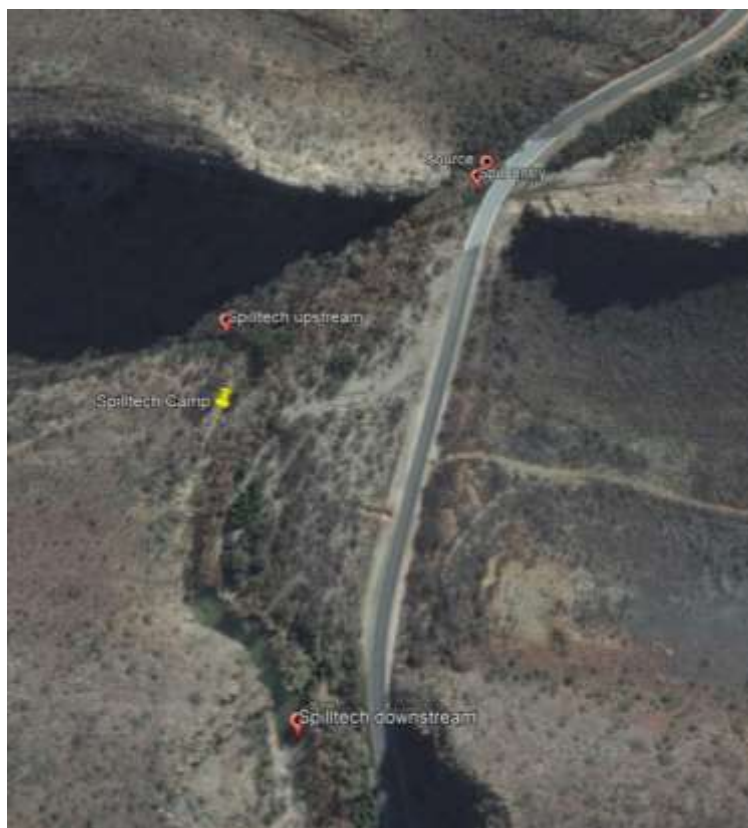
Figure3.6 Additional sediment samples from the active channel of the river within the impact zone were taken in August 2018.

Soil samples for the analysis of hydrocarbons were collected from all five monitoring sites, as well as from the source area and the substrate in the river at the point of entry of the diesel. These additional points of sample collection are shown in Figure 3.6, relative to Site 2 (i.e. Spiltech Camp).

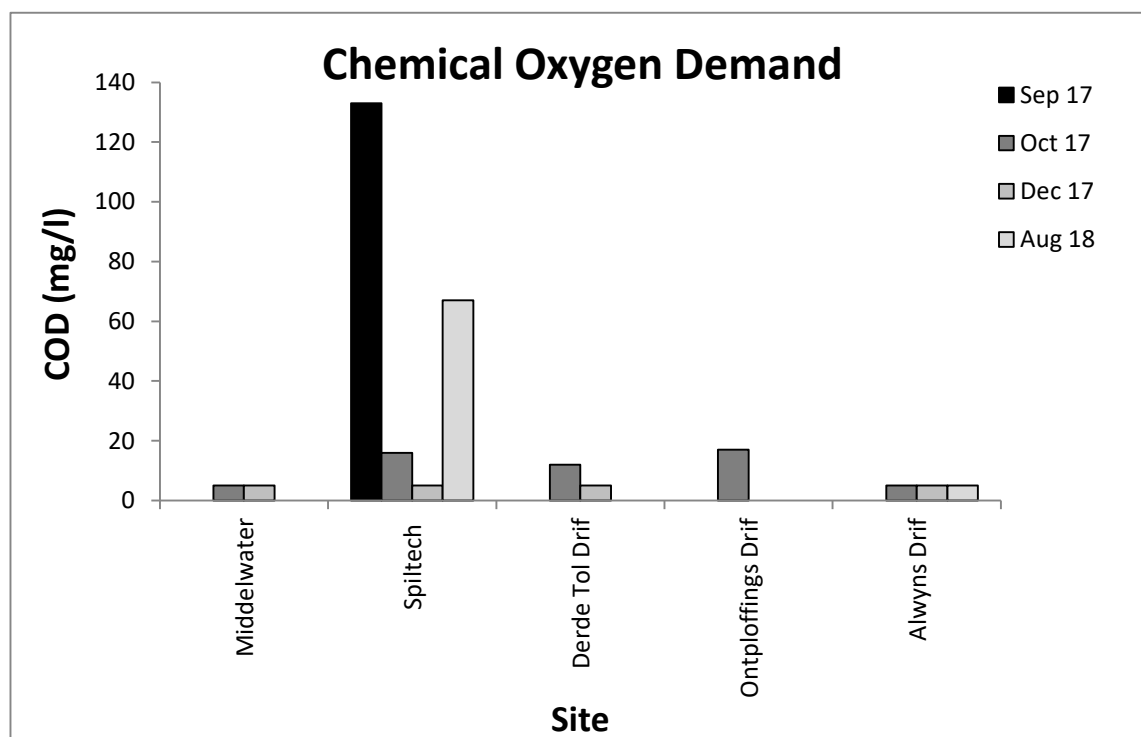
Figure 4.1 Chemical Oxygen Demand (COD) measured between September 2017 and August 2018.

The oxygen concentration at the downstream control site (i.e. Site 5: Aalwyn Drif) in August 2018 (Table 4.3) was similar to that measured during the Baseline Study as well as in December 2017 and, with a value of 10.1 mg/l, is indicative of a system that is well oxygenated and in good condition. Although oxygen concentrations dropped to 5 mg/l within the impacted zone immediately following the diesel spill (see Ewart-Smith 2017), concentrations of 9 mg/l were recorded at Site 2 (Spiltech) in December 2017 indicative of relatively unimpacted conditions. By contrast, a low DO concentration (i.e. 6.4 mg/l) was measured in the pool downstream of Spiltech Camp in August 2018 (Table 4.3). The low DO concentration is coupled with a relatively high Chemical Oxygen Demand (COD) of 67 mg/l. This suggests that the low DO concentration may be a result of the breakdown of certain chemicals and decomposition of organic matter. Immediately following the diesel spill in August 2017, the DO concentration within the same pool was 7.2 mg/l with a COD of 133 mg/l but recovered quickly such that COD in December 2017 at all monitoring sites was below the detectable limit of 10 mg/l (Figure 4.1). Although no hydrocarbons were detected in either the water column or sediments at this site during August 2018 (Table 4.1 and Table 4.2), the elevated COD at the Spiltech pool site may be indicative of ongoing breakdown of hydrocarbons from the sediments, possibly not detected by a single grab sample of the substratum, although no slicks or surface sheens were evident on disturbance of the substratum. Considering that hydrocarbons are still present in the substratum a short distance upstream (Table 4.1, Spiltech u/s), this may be a possibility but is nevertheless unclear.

Interpretation of the water chemistry data, particularly the elevated COD concentrations and low dissolved oxygen levels in the pool downstream of site 2 (Spiltech Camp) was complicated by the drought conditions in August 2018 but suggest the possibility that these adverse conditions may be a response to the breakdown of hydrocarbons still present in the system.

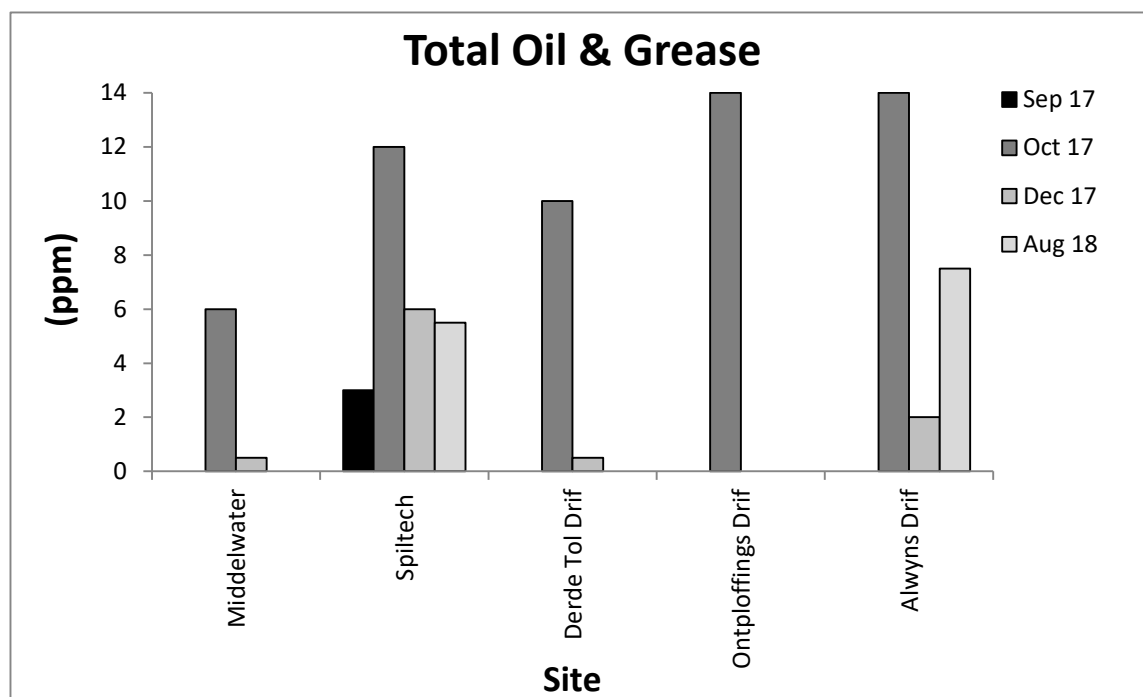
Figure 4.2 Total Oil and Grease measured between September 2017 and August 2018.

In August 2018, Total Oils and Grease (TOG) were lower within the impact zone at Spiltech compared with that at the downstream control site (Aalwyns Drif) (Table 4.4 and Figure 4.2). These concentrations are below the United Nations Environmental Programme (UNEP 1992) maximum permissible limit of 10 ppm (or mg/l) for oils and thus the presence of soluble hydrocarbons in the water column at the time of sampling in August 2018 do not pose a risk to freshwater ecosystems. These concentrations are significantly lower than those measured at sites within the impact zone (Spiltech) and downstream as far as Aalwyns River in October 2017, although TOG concentrations were of insignificant concern by December 2017 (Figure 4.2)

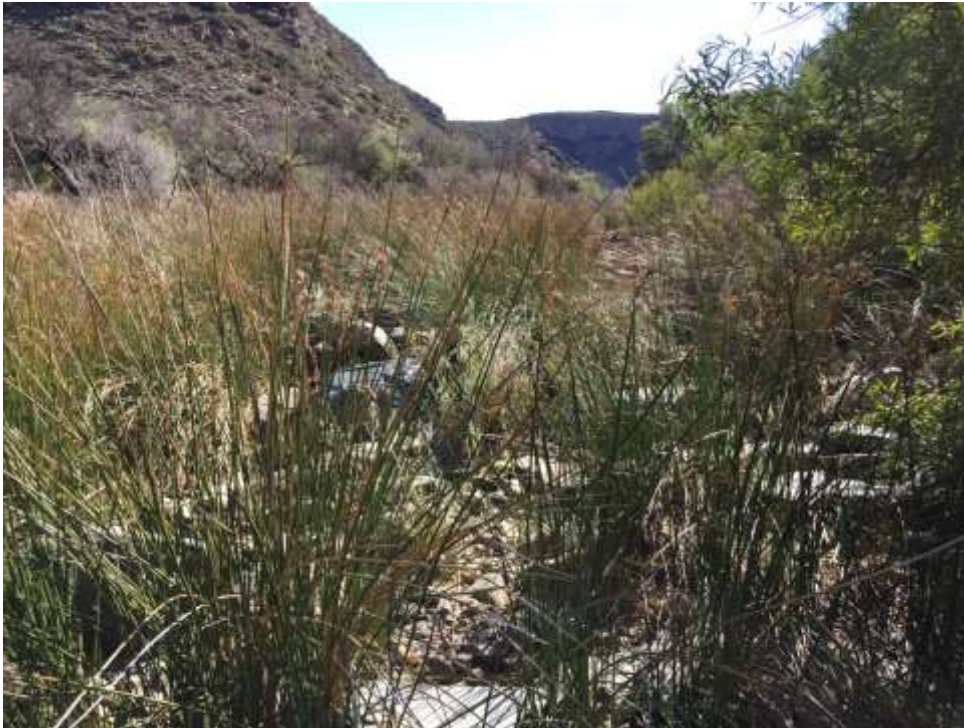
Figure 4.4 The lack of high flows over the past year has permitted wetbank vegetation (mostly *Pseudoschoenus* sp. to invade the active channel of the Meirings River)

There is no visual evidence of any adverse impacts to the wetbank marginal vegetation (mostly *Pseudoschoenus sp.*) that was coated with diesel fuel immediately following the spill within the impact zone (as far as Derde Tol Drif). *Pseudoschoenus sp.* was in full flower in October 2017 following the spill event and evidence of new buds present in August 2018 suggest that these plants will flower again this spring. The lack of high flow events that act to scour the active channel and maintain it free of vegetation has resulted in a clear invasion of the channel by wetbank plant species over the past year (Figure 4.4). The drought conditions, coupled with abstraction upstream therefore appear to have had a more detrimental effect on the biotic integrity of the channel compared with the effect of the diesel spill in the short term.

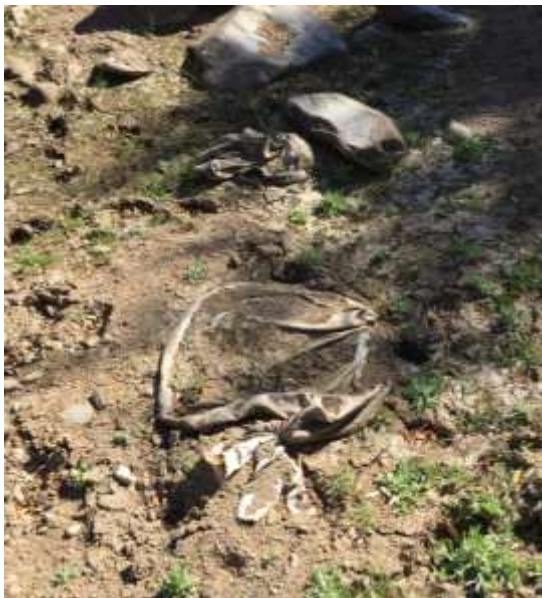
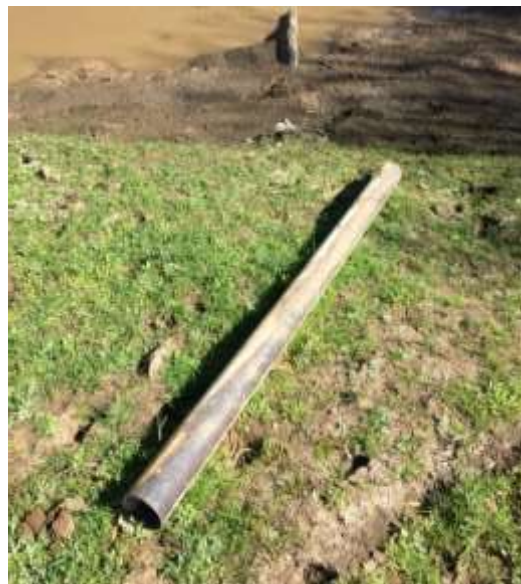
Figure 4.5 Sandbags and pipes used in the clean-up operations of the Meirings River following the diesel spill should be removed from the channel.

Sandbags and pipes used in the mechanical clean-up operations within the impact zone of the Meirings River remain within the channel (Figure 4.5). It is recommended that these items, as a source of litter to the system be removed while the system is dry and easily accessible.

Residual components such as sandbags and pipes used in the mechanical clean-up operation impact on habitat quality of the Meirings River as far down as Derde Tol Drif and thus it is recommended that they are removed from the system while drought conditions prevail and the area is easily accessible.
