UPPER JUKSKEI RIVER CATCHMENT REHABILITATION

FRESHWATER SPECIALIST STUDY

Advisian

July 2018

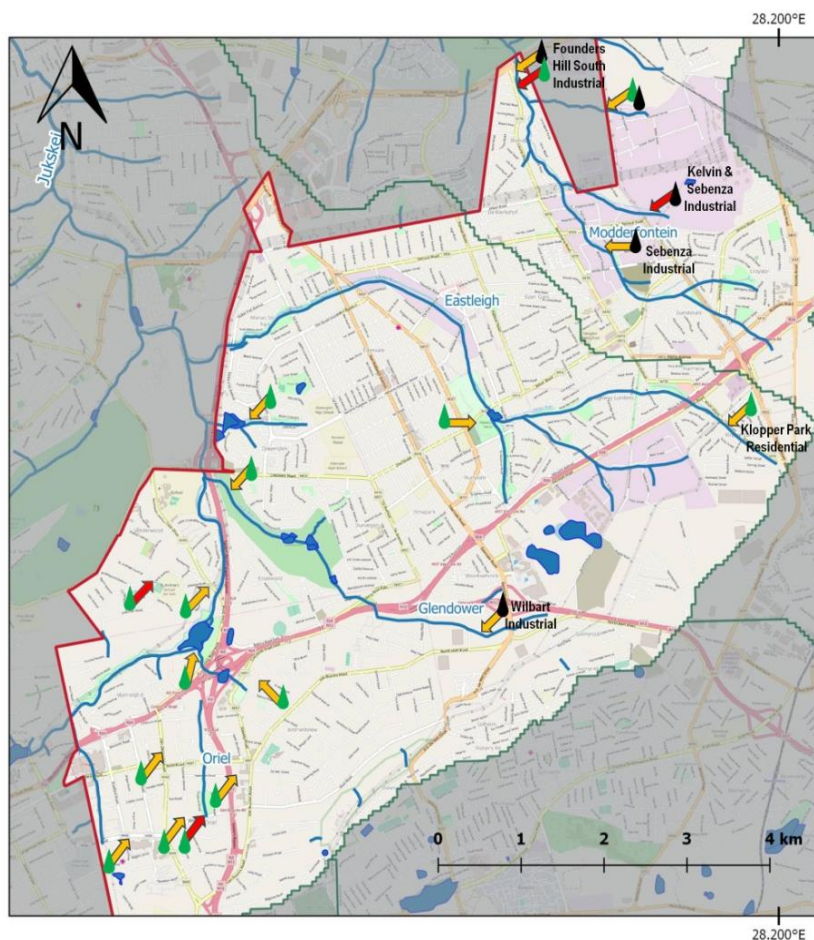
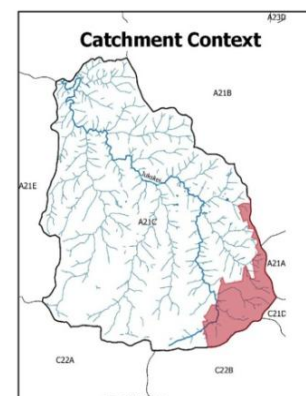
A number of pollution sources were identified during this study (see below). This map presents the best available information at the time of writing, but may look substantially different in a few months time. As infrastructure is repaired or maintained a problem spot may disappear, however a new one will inevitably present itself.

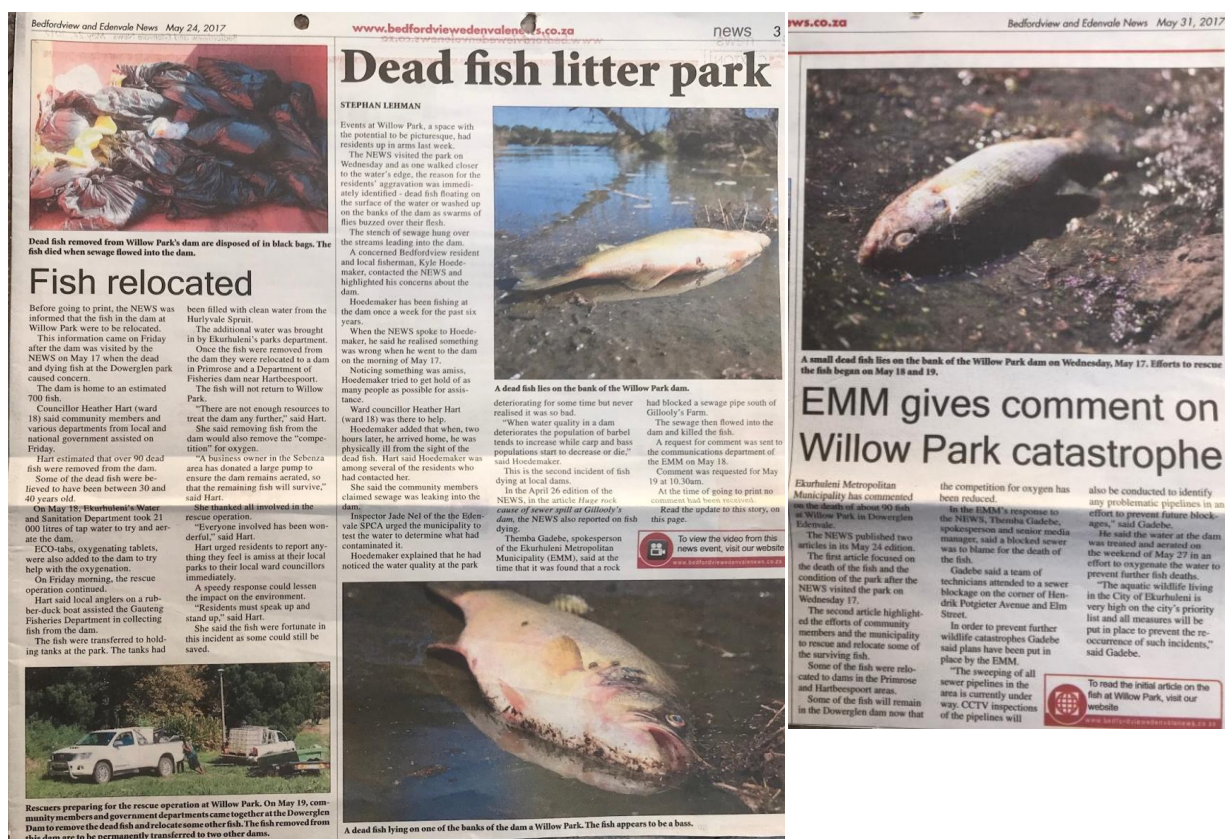
Figure 6. Articles from the Bedfordview & Edenvale Times during May 2017 reporting the fish kill at Willow Park.

originate from stormwater runoff. A number of articles in the Bedfordview and Edenvale Times (May, 2017; Figure 6) reported water quality issues in the dam which resulted in a fish die-off, probably due to low oxygen. Reportedly, sewage was flowing via the stream into the dam due to a blocked sewer.

Of concern is that efforts were made to rescue and move dying fish from the dam when the species involved appear to be carp and bass. As alien invasive species, it may be necessary to obtain a permit from the Department of Environmental Affairs to move fish in this category to another location, so as to restrict their distribution and impact on native fish and aquatic ecosystems where they do not yet occur. In future, the transfer of these fish species between waterbodies must be considered with caution.

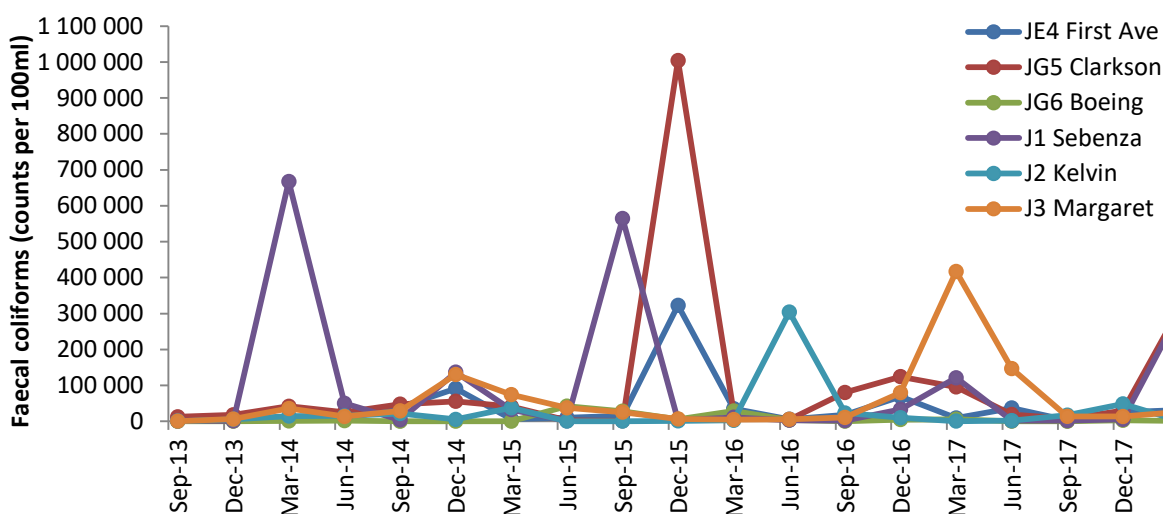
Figure 8. Faecal coliform counts (per 100 ml) measured at six CoE water quality monitoring points in the study area.

Therefore the guideline most appropriate for comparison would be the South African Water Quality Guidelines for Recreational Water Use (DWAf, 1996). The target water quality guideline for intermediate contact recreation is 0 – 1000 counts per 100ml. Water quality monitoring results show extremely high levels of faecal coliforms throughout the period of measurement, and most sites are almost permanently contaminated (**Error! Reference source not found.**). The only sites where water quality very occasionally meets the target are at the outflow of Gillooly’s Dam (JG6) and Kelvin Stream (J2).

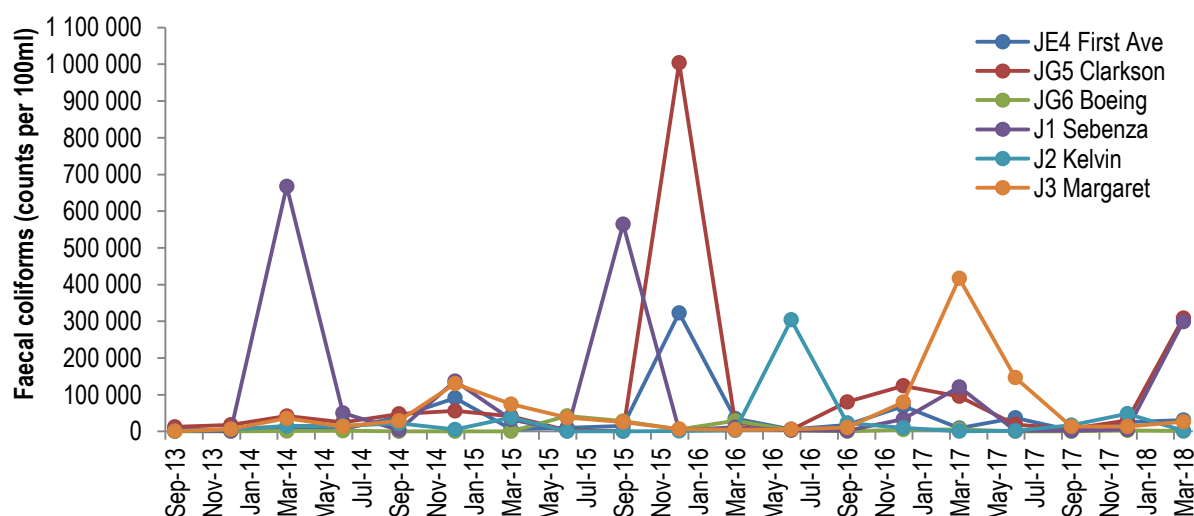
Figure 9. Faecal coliforms measured at six monitoring sites bi-monthly from 2013 to 2018 by the City of Ekurhuleni.

Faecal coliforms are considered an indicator of sewage. Although on their own they are not detrimental to the ecological health of rivers, they provide evidence of recently discharge sewage effluent which is rich in the nutrients responsible for eutrophication (enrichment) of water resources. Their numbers are also closely correlated to pathogen causing viruses and bacteria. From a human health perspective, the presence of elevated faecal coliforms is a useful indicator that the water may pose a human health risk depending on the level of exposure.

It is not anticipated or recommended that humans drink raw water from any of the watercourses in the study area so comparison to drinking water guidelines is not practical. Given that many watercourses occur in recreational parks, it is conceivable that there may be a degree of light exposure to the water through splashing or playing. Therefore the guideline most appropriate for comparison would be the South African Water Quality Guidelines for Recreational Water Use (DWAF, 1996). The target water quality guideline for intermediate contact recreation is 0 – 1000 counts per 100ml. Water quality monitoring results show extremely high levels of faecal coliforms throughout the period of measurement, and most sites are almost permanently contaminated (Figure 9). The only sites where water quality very occasionally meets the target are at the outflow of Gillooly’s Dam (JG6) and Kelvin Stream (J2).

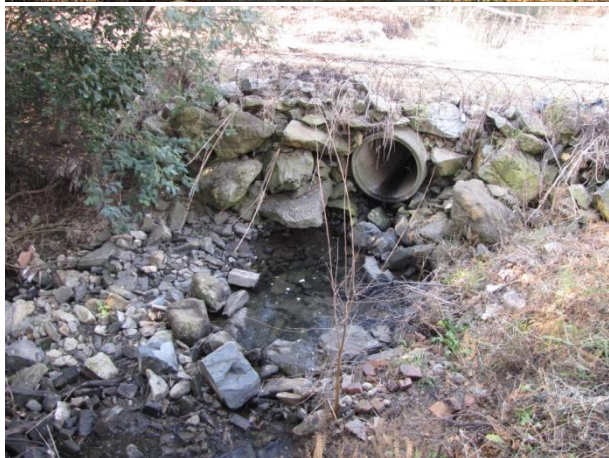
West of the boundary between CoE and CoJ, downstream of piped stream-flow under a dirt road crossing. Water quality and diatoms sampled upstream from a seep, and SASS5 attempted at the pictured site, which proved inadequate. Start: Lat. -26.110250°, Lon. 28.170415° End: Lat. -26.110167°, Lon. 28.173378° Distance: 300 m

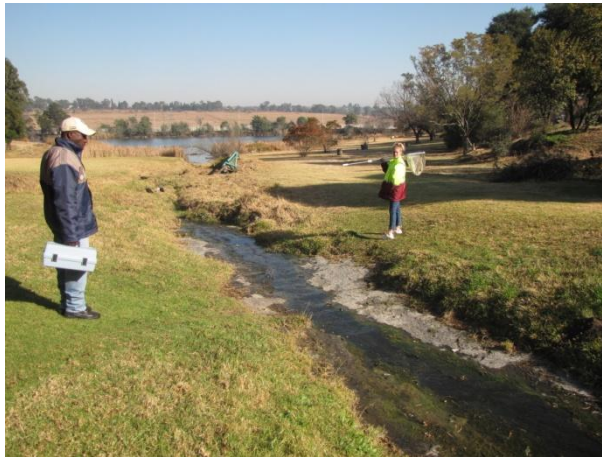
W1
Willow Park

Upstream of the dam at Willow Park, water quality and diatoms sampled from the stream. SASS5 not possible due to unsuitable habitat and inadequate flow.

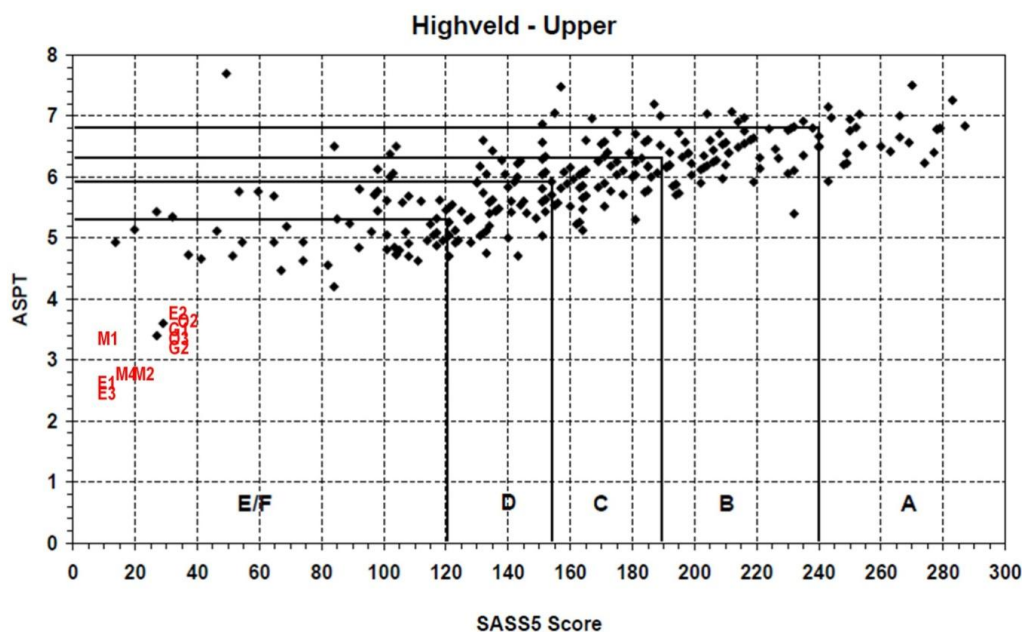
Figure 12: Biological bands for the upper Highveld depicting the plotted study sites.

The results of the SASS5 survey were fairly similar across sites, with each site sampled categorized as E/F, Seriously Modified in the context of the upper Highveld ecoregion (Table 10; Figure 12). This result indicates that the taxa present were highly tolerant of elevated pollution levels. While some sites may be less impacted than others, generally speaking aquatic ecosystem health is very poor in all the watercourses studied, as reflected by the macroinvertebrate assemblage. There was a general lack of the gravel, sand and mud (GSM) biotope, as well as instream vegetation, which is likely related to annual flooding and scouring of the stream bed. This was reflected in the generally poor habitat scores. Habitat was further affected at Site E1 where the stream bed was mostly concrete, and at Site M3 where water levels were too low to permit sampling of a wide range of biotopes. The actual SASS sheet for each site is available in the Appendices.

Site	SASS score	No. of taxa	ASPT	Habitat (%)	Ecological category
M1	16	5	3.2	33	E/F
M2	23	8	2.9	29	E/F
M3	14	3	4.7	13	E/F
M4	20	7	2.9	36	E/F
E1	11	4	2.8	13	E/F
E2	35	9	3.9	49	E/F
E3	10	4	2.5	49	E/F
W1*	-	-	-	-	-
G1	35	10	3.5	40	E/F
G2	34	11	3.1	36	E/F
O1*	-	-	-	-	-
O2	38	11	3.5	38	E/F
O3	34	11	3.1	40	E/F

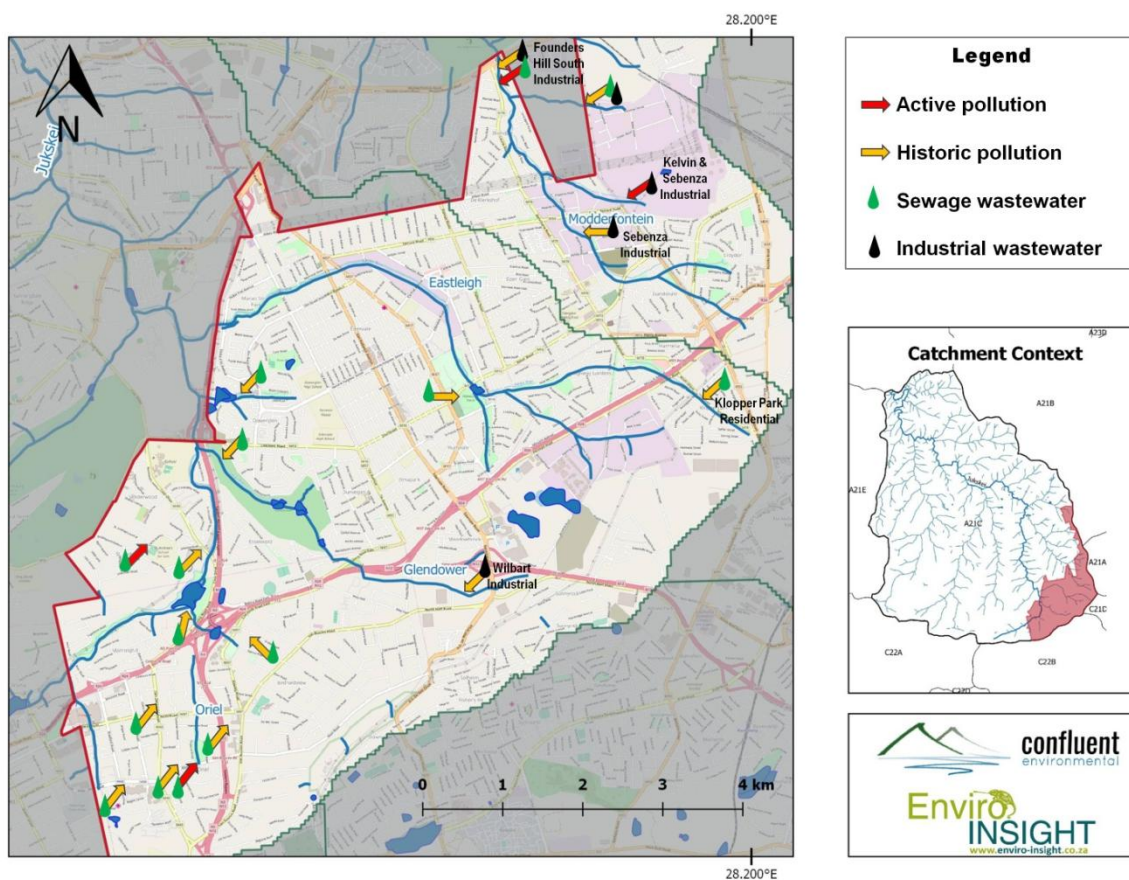
Figure 18. Map depicting active and historic sources of sewage and industrial pollution in the upper Jukskei River catchment.

Both historic and current pollution sources have been identified and mapped (Figure 18). However, this list of locations could look entirely different in three months time. For this reason, a few underlying issues regarding the prevention, reporting of and response to pollution events are discussed below (Table 17). The identification of these issues and suggestions for their improvement are provided with the aim of reducing pollution and improving the response time to pollution events, thus limiting their damage to aquatic ecosystems. The aim is also to shift the focus to preventative and proactive management versus crisis management. This list is based on feedback from concerned stakeholders and councilors who have firsthand experience with the current system. It is recommended that these suggestions be considered and incorporated into the rehabilitation plan where feasible.

Mapped pollution sources in Figure 18 show that historic pollution events have occurred at several points, while current pollution is occurring at four sites (that we are aware of). The sites mapped as historic problem areas indicate locations with intermittent and recurring problems, as opposed to a single incident. Industrial waste has been observed downstream of almost every industrial area in the study area. This occurs on an intermittent basis and it is difficult to pinpoint the source because of the large areas being drained. Sewage pollution along the Modderfontein Stream system will hopefully improve in the future due to the construction of the Modderfontein Outfall Sewer which is currently underway.
